2025 Annual Pitt
Transportation Forum

I-95 Bridge Collapse

*Temporary Roadway &
Permanent Bridge Replacement*

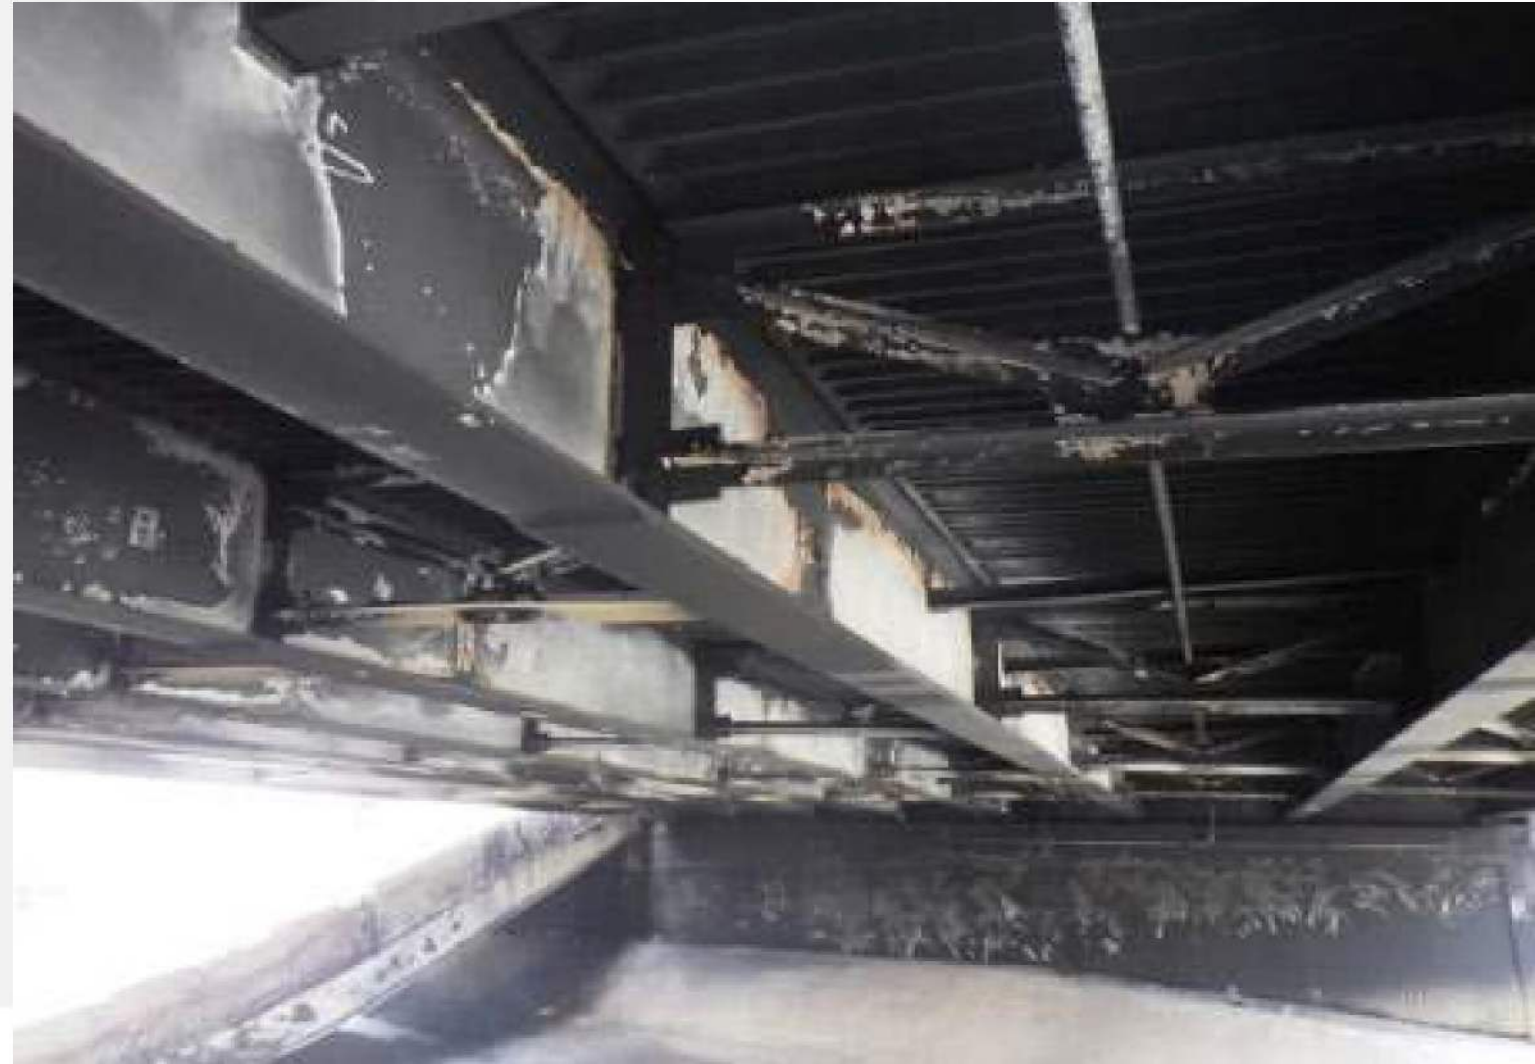
- June 11th
- Visual & hands-on
- Heavy soot staining limited visual inspection
- Could not inspect connections for displacement-induced cracking

*Underside of the southbound structure, looking back.
Note the heavy soot staining*

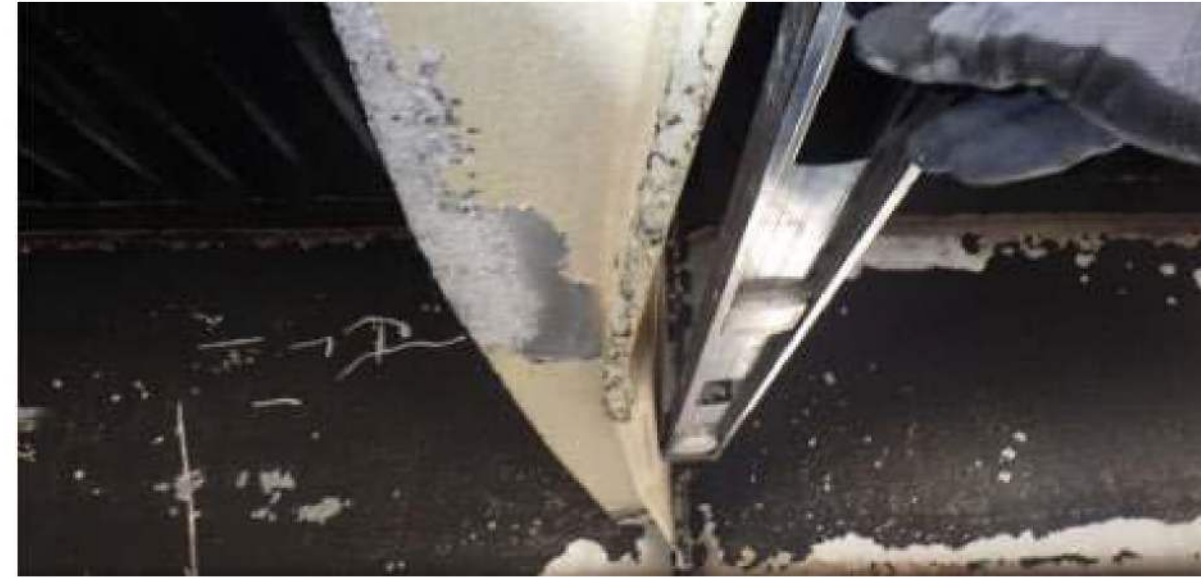
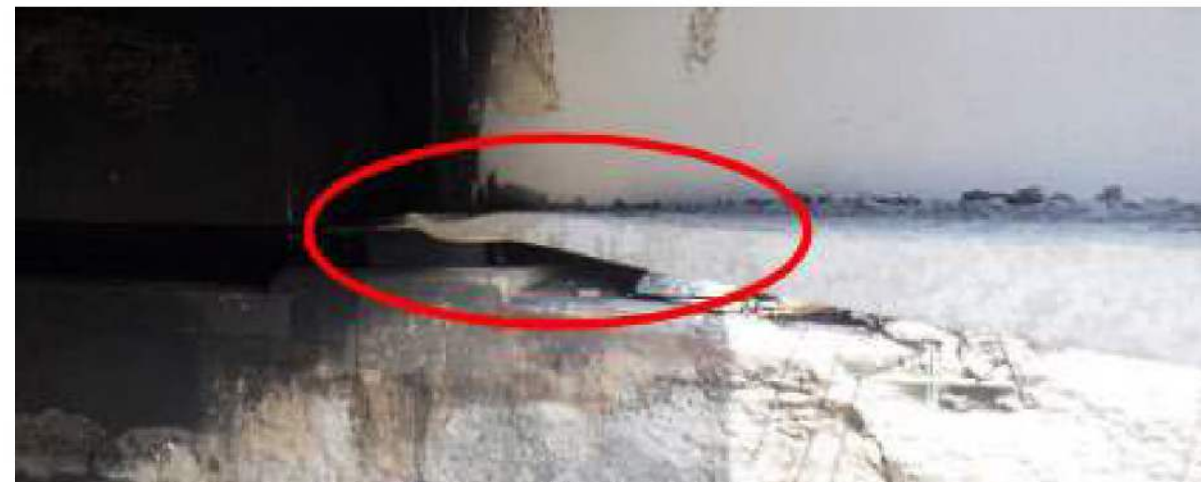
Web distortion up to 2 ½"

Bottom flange lateral and vertical distortion

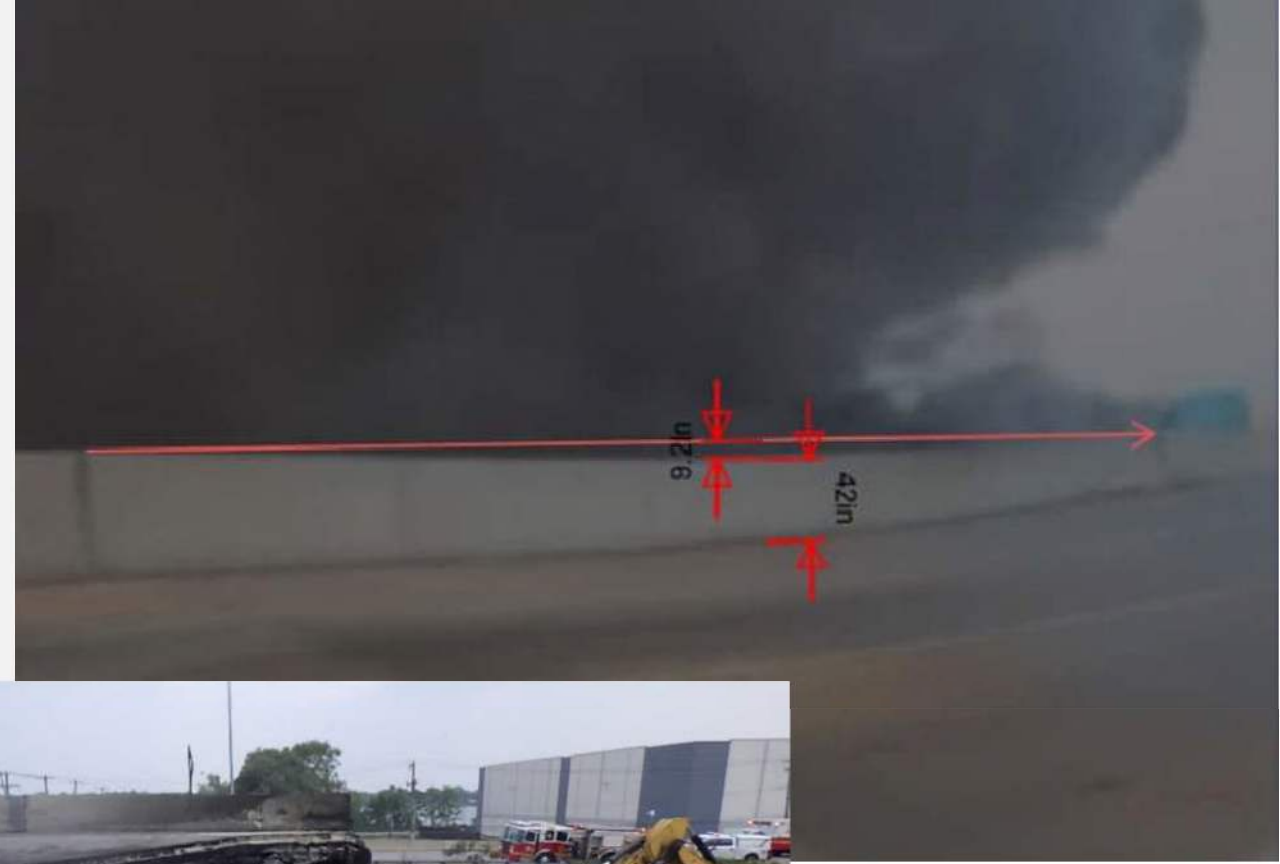
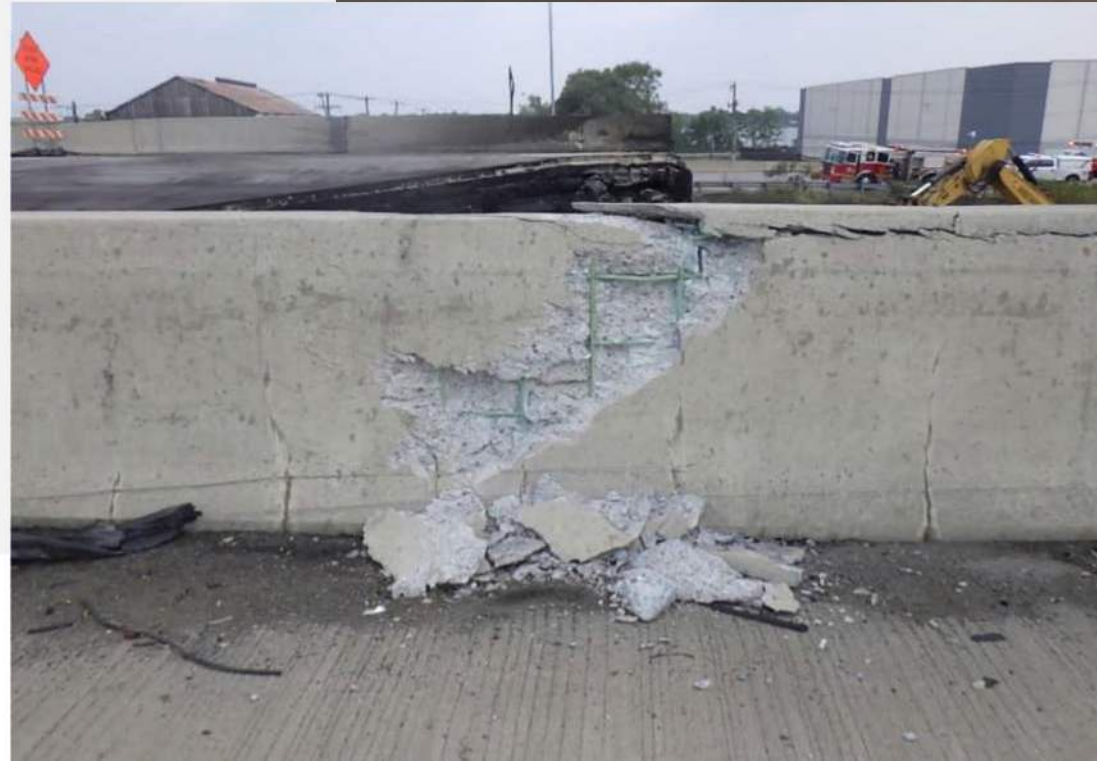
- Social media image of SB
- During fire: midspan sag ~9"
- During inspection: no sag

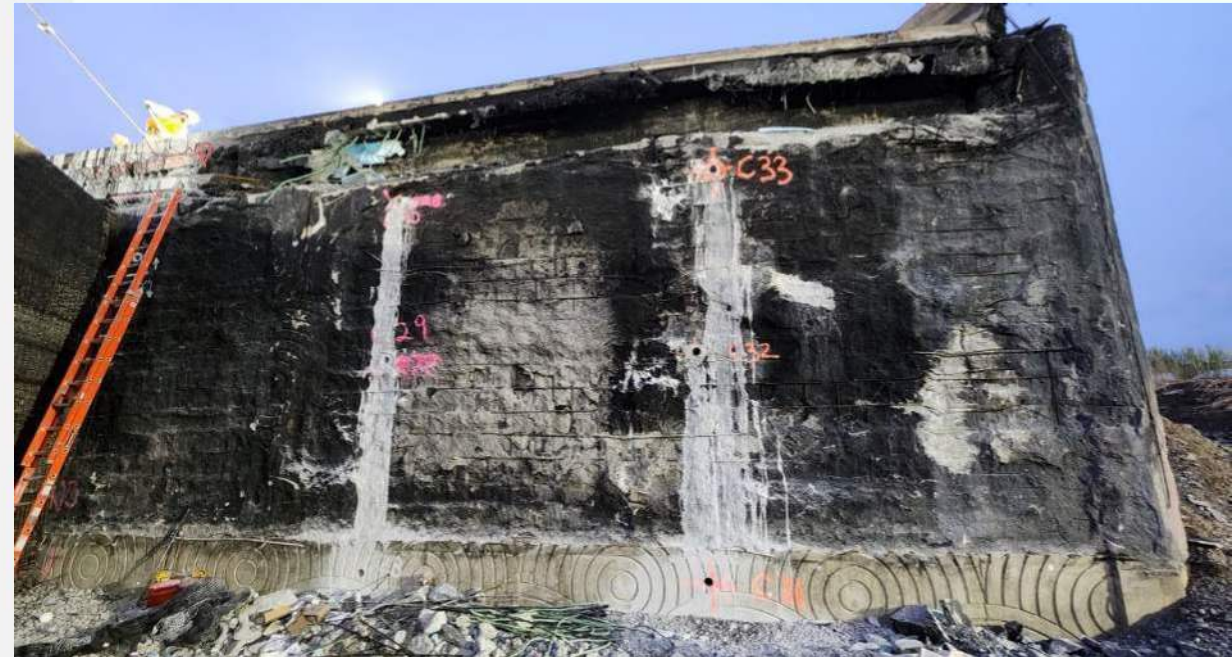
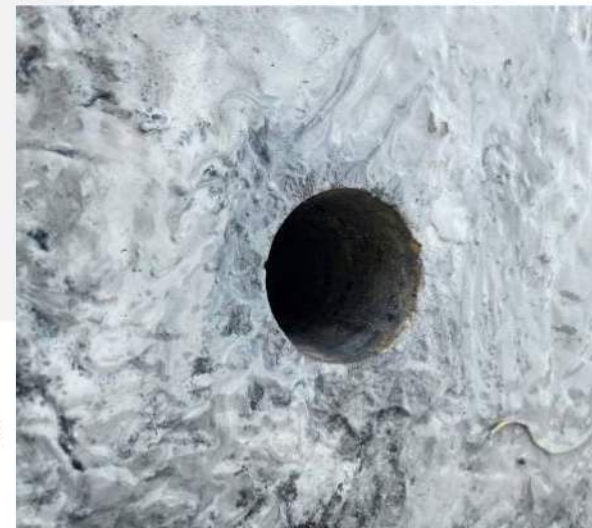
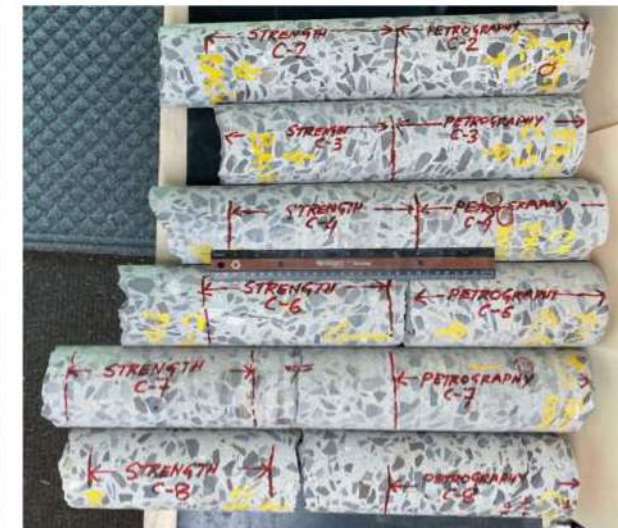
3³/₄" diameter core

- Concrete cores
- Microcracks
- Assess capacity
- Microscopic, petrographic & fluorescent (UV) light examinations
- Fire spalled up to 6" to 7" of concrete
- Repair / replace depths = 1" to 4" with overall removal up to 9" from original face
- Compressive strength = 4700 psi to 6610 psi
- Estimated temperature in concrete
 - 300°F to 500°F

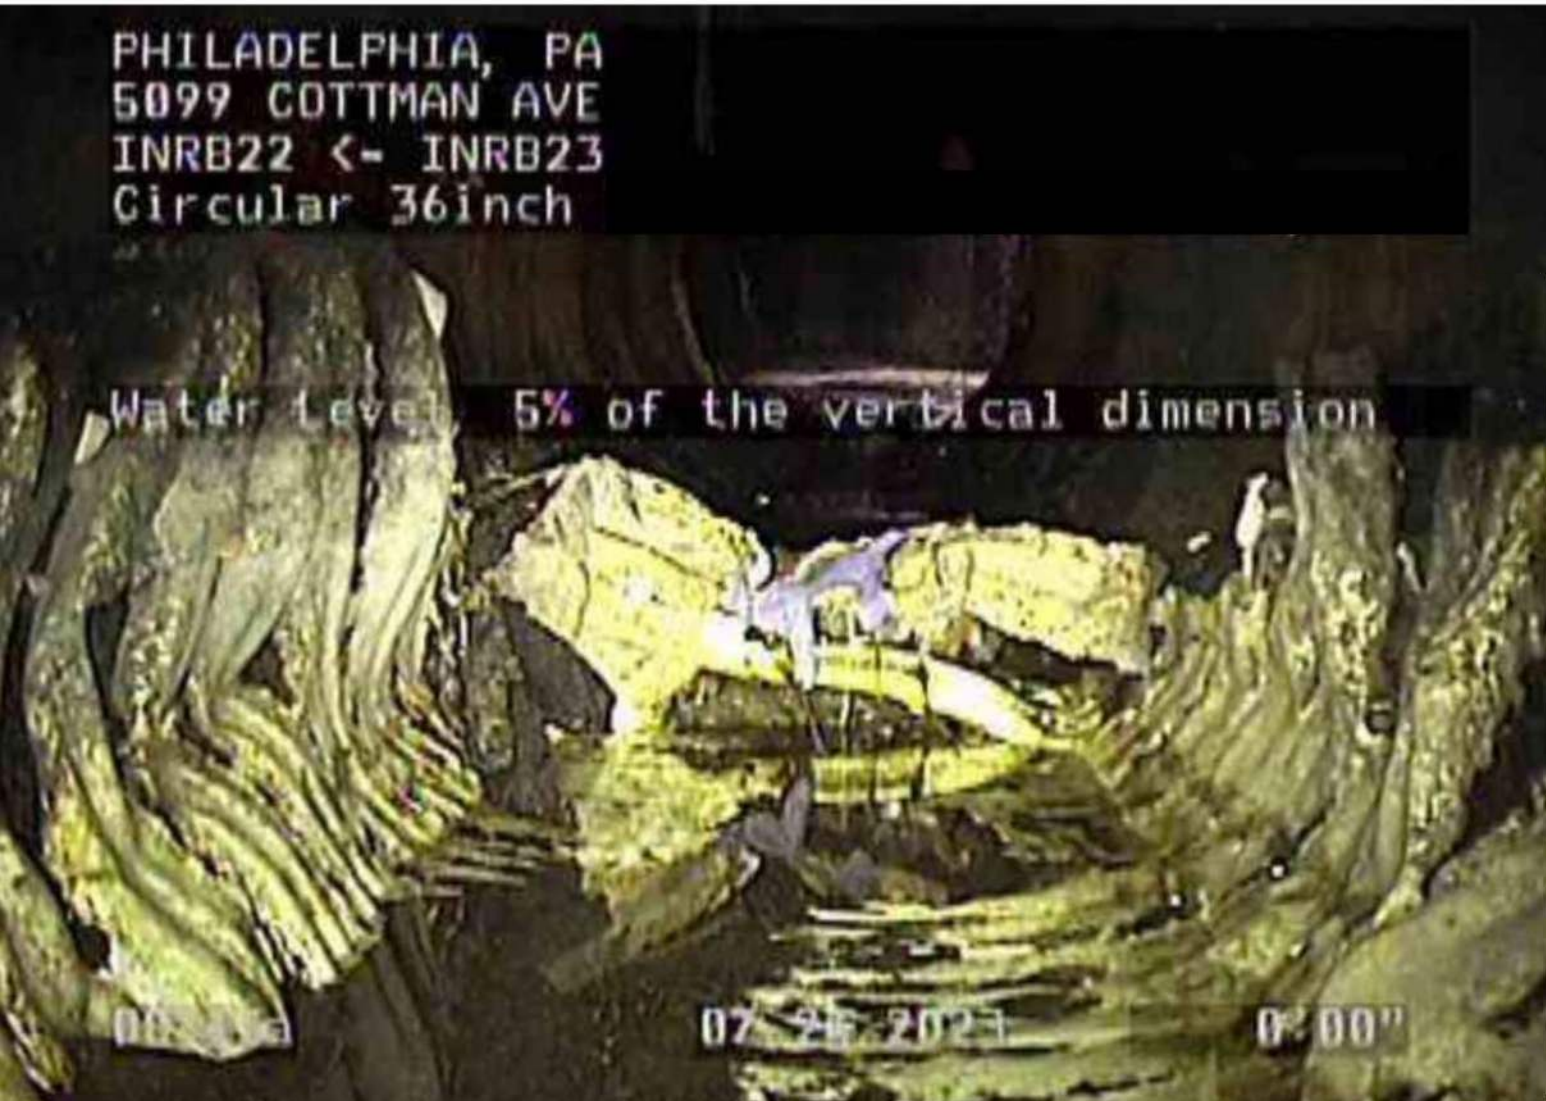
Drainage Pipe Damage

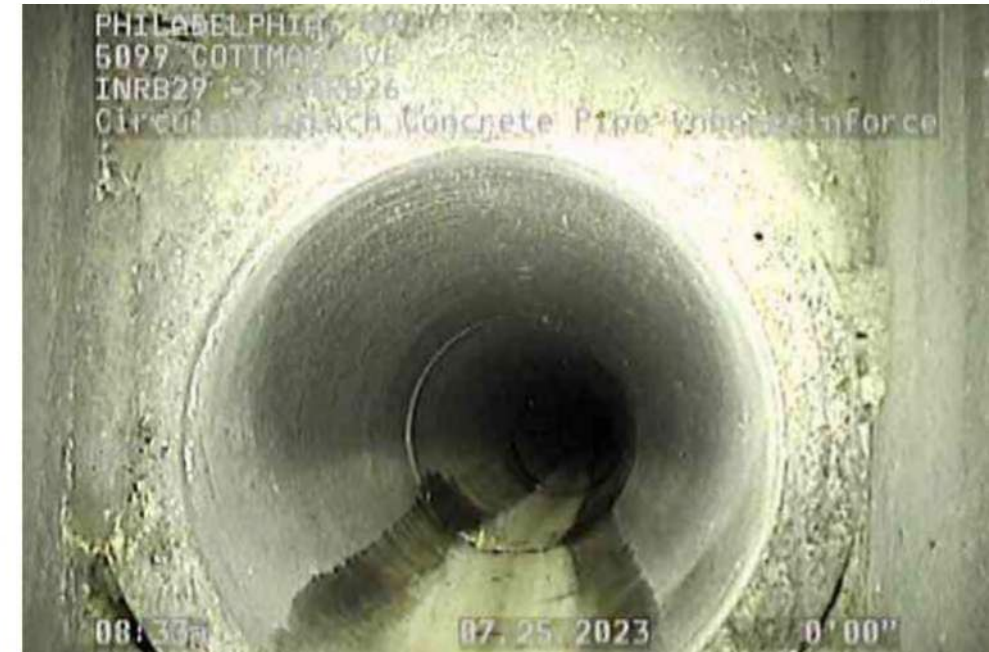
Plastic Pipe Damage

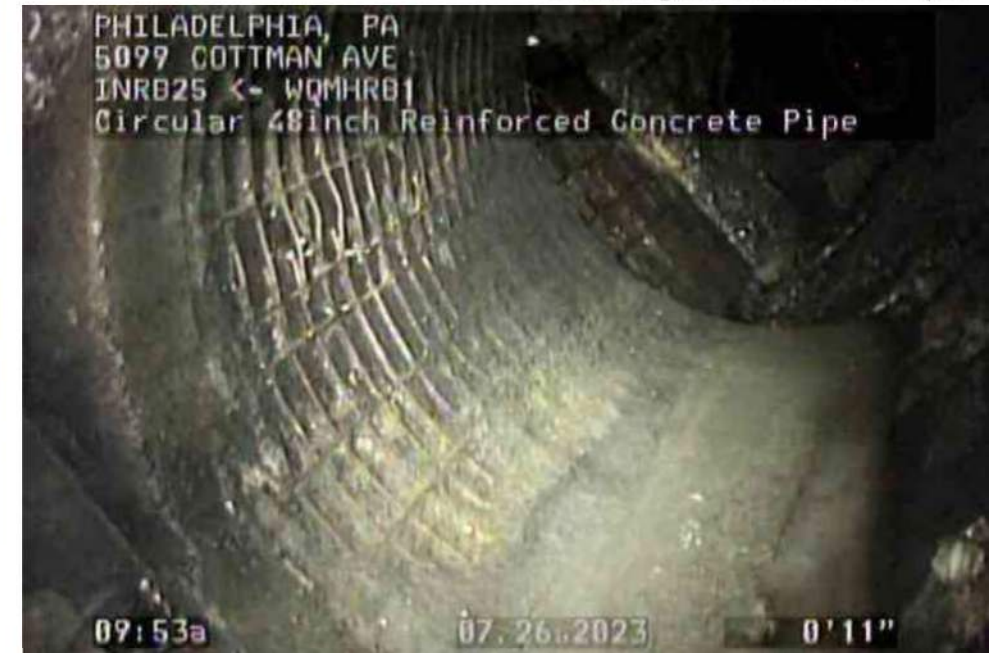
Damaged Concrete Pipe
