FINAL REPORT IRISE-23-P22-01-01 | SEPTEMBER 2023

Identifying Major Causes of Construction Accidents

CENTER FOR IMPACTFUL RESILIENT INFRASTRUCTURE SCIENCE & ENGINEERING

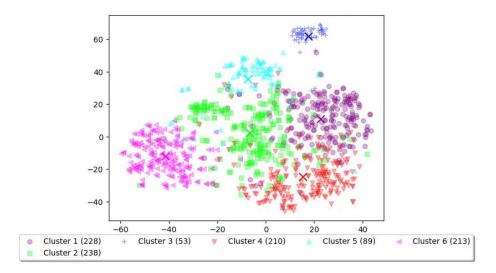
Figure 1: Example K-Means clustering of incidents (6 clusters)

With the database, the final narratives were isolated to calculate dense numerical vectors (1,536 dimensions) of textual embeddings that are crafted to withhold contexts and semantic meanings of individual incidents. Clustering these embeddings is essential for dissecting major accident causes, and machine learning algorithms like K-means are employed for this purpose. Additionally, techniques like t-Distributed Stochastic Neighbor Embedding (t-SNE), are utilized to visualize this high-dimensional data into two dimensions effectively and reveal clusters within complex datasets (van der Maaten & Hinton, 2008). The ideal number of clusters was found to be six clusters in this study, as shown in Figure 1, which also demonstrates the application of the t-SNE algorithm.

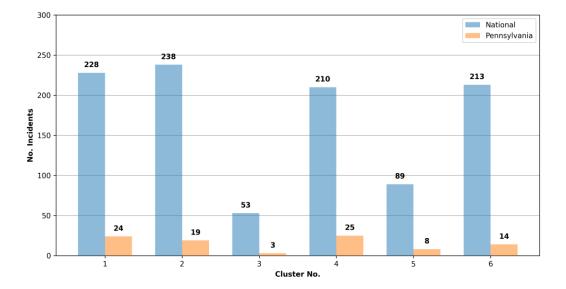
Figure 2: National vs. Pennsylvania cluster percentages

Additionally, the study delves into the technical aspects of using language models, including prompt refinement and manual response evaluation, to summarize clusters and identify major causes of accidents. This approach revealed six major causes of accidents, a breakdown of national to state level cluster percentages is presented in Figure 2:

- Cluster 1: Stuck by Vehicle or Heavy Equipment
 - o 228 cases | 99.6% Hospitalization | 1.8% Amputations
- Cluster 2: Contact with Objects or Equipment
 - o 238 cases | 95.8% Hospitalization | 8.4% Amputations
- Cluster 3: Heat Related
 - o 53 cases | 100% Hospitalization | 0% Amputations
- Cluster 4: Falling Objects or Personnel
 - o 210 cases | 99% Hospitalization | 1% Amputations
- Cluster 5: Heated Materials or Equipment
 - o 89 cases | 100% Hospitalization | 1.1% Amputations
- Cluster 6: Upper Limb Injuries
 - o 213 cases | 49.8% Hospitalization | 72.3% Amputations

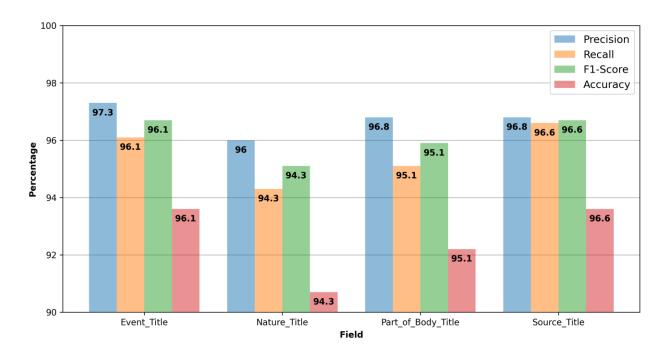
Figure 3: Evaluation metrics of LLM classification

The language model was also employed for incident classification using specific fields from the OSHA SIR database. Evaluation metrics such as accuracy, recall, specificity, precision, and F1Score were utilized to assess the model's performance in various classification scenarios, as shown in Figure 3.

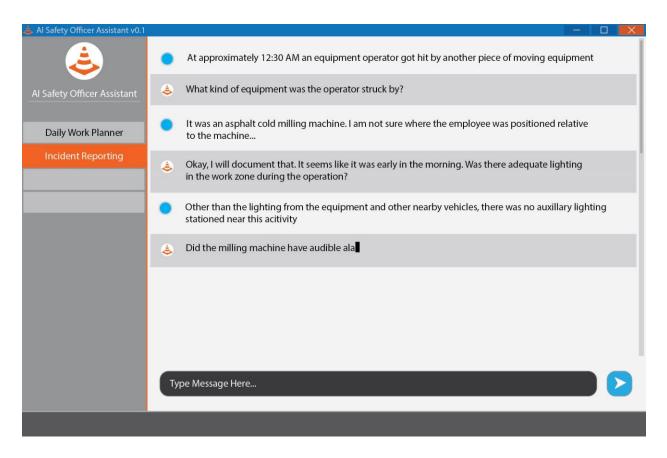
Figure 4: Mock user interface of AI Safety Officer Assistant program

This study culminated in a proposal for the implementation of the "AI Safety Officer Assistant" within the highway construction industry. The proposal aims to address the persistent issue of high accident rates and fatalities in this sector, which pose financial and safety risks. The AI Safety Officer Assistant utilizes natural language processing to streamline incident reporting and hazard communication and generation of daily work activity plans with a focus of safety, enabling efficient analysis of unstructured data. It offers the potential to reduce costs, improve productivity, and enhance safety management practices, aligning with transportation agencies' objectives to minimize accidents and ensure worker well-being. While there are initial setup costs, the long-term benefits are expected to outweigh these expenses, making it an economically viable solution.

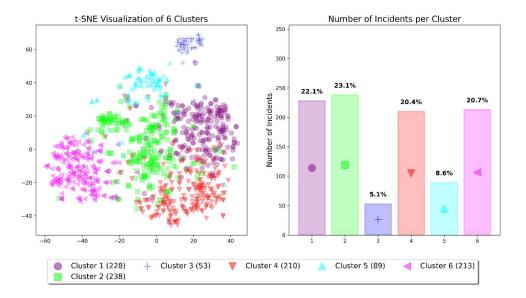
Figure 5: Example incident clustering (6 clusters) and associated percentages

cluster count, as demonstrated in Appendix B: Section 3. This approach involved considering both quantitative and visual aspects to determine the most suitable cluster count for the K-Means algorithm, ultimately leading to the selection of the ideal number of clusters for further investigation. Consequently, six clusters (Figure 5) were chosen for further analysis as they struck a balance, occupying distinct regions with minimal overlap and demonstrating a notable shift in average SSE.

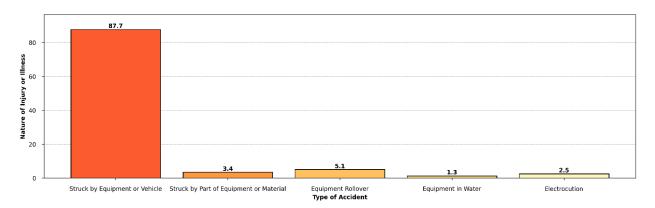
Figure 8: Percent of equipment accidents vs. type of accident (Hinze & Teizer, 2011)

Hinze and Teizer (2011) further dissected OSHA reported accidents involving on-site equipment and workers. The data shown in Figure 8 relate the percentage of equipment accidents to the type of accident. Struck-by equipment or vehicle in the work-zone is a leading cause of accidents related to equipment (Hinze & Teizer, 2011).

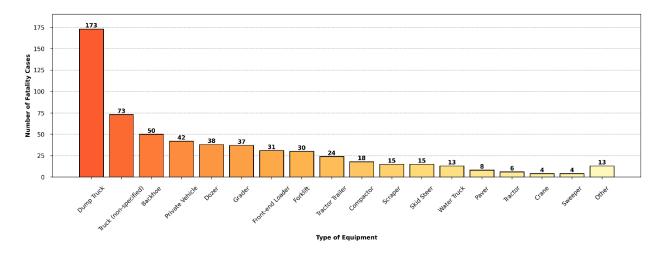
Figure 11: Number of fatal cases by equipment type (Hinze & Teizer, 2011)

reconstruction, many activities include earthmoving equipment to prepare the site. The four most common types of earthmoving equipment are the backhoe, bulldozer, excavator, and scraper. It was found that a majority of earthmoving equipment accidents will result in a fatal condition, with the highest frequency of fatalities when the backhoe is involved in the scope of work (Kazan & Usmen, 2018). Of the investigated types of equipment, the dump truck results in the most frequent number of fatalities – shown in Figure 11 (Hinze & Teizer, 2011).

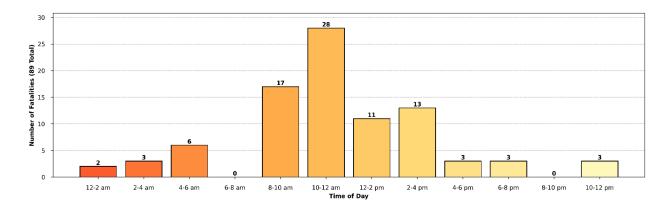
Figure 13: Number of vision-related fatalities at various times (Hinze & Teizer, 2011)

The time of day contributes to the frequency of other types of accidents occurring. This is prevalent in the various types of vision related accidents (i.e., the excessive illumination during high sun or the lack of illumination during the nighttime). Figure 13 depicts vision related fatalities with the corresponding time of day they were reported.

The data from this study shows that from 10:00 A.M. to 12:00 A.M. resulted in the greatest number of fatalities (Hinze & Teizer, 2011). An additional study by Hinze et al. (2005) on the nature of struck-by accidents using OSHA data from 1997 to 2000 resulted in the highest frequency of struck-by fatalities at both 9:00 A.M. and 1:00 P.M. as shown in Figure 14 (Hinze, Huang, & Terry, 2005). Although these studies included data from different years, there is a consensus that more accidents occur during peak hours of construction.

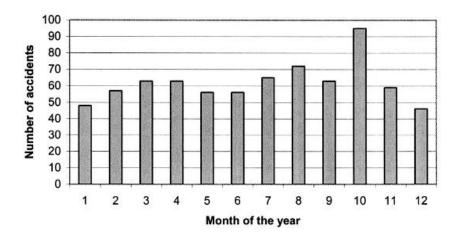
Figure 15: Number of struck-by accidents by month of the year (Hinze, Huang, & Terry, 2005)

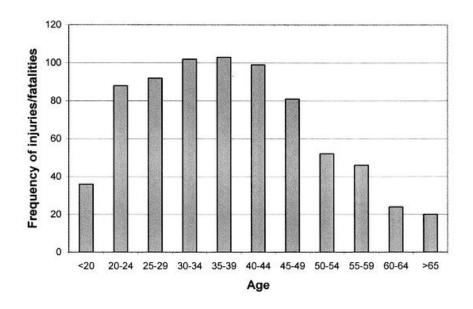
Figure 16: Frequency of struck-by accidents by age (Hinze, Huang, & Terry, 2005)

In addition to this classification, further study on the age of a worker can impact the likelihood of an accident. The nature of struck-by accidents the distribution of frequency of injuries/fatalities by age is shown in Figure 16 (Hinze et al. (2005)).

From this distribution, it is shown that workers within the age of 30 to 44 have a higher frequency of injuries/fatalities than others. This finding indicates that middle aged workers are more likely to be involved in an accident, which may lead to younger and older workers to be more precocious in their activities. Workers who are within the range of higher frequency accidents may have had less recent training which could accompany the higher frequency of incidents, yet more research is required to make any significant conclusions.

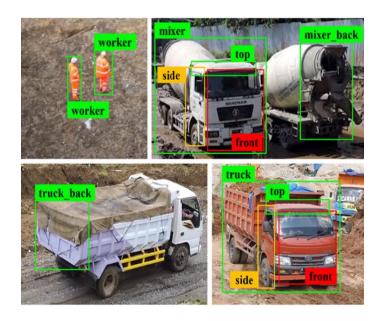
Figure 17: Various annotations of workers and equipment from CVB method (Yan, Zhang, & Li, 2020)

distance between 3D objects due to the projection of a 2D spatial relationship (Yan, Zhang, & Li, 2020). In addition to the potential distortion from the two-dimensional projection to 3D, there are other concerns with the accuracy of this method of proximity detection. Since construction equipment (heavy vehicles) have relatively large sizes, there exists an inevitable self-occlusion where the 2D image of the equipment overlaps itself. This self-occlusion ultimately effects the accuracy of proximity detection (Yan, Zhang, & Li, 2020).

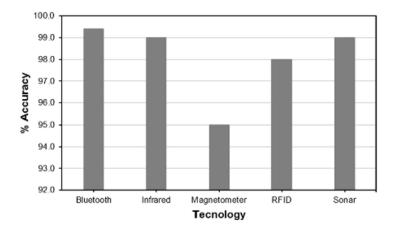
Figure 18: Accuracy of selected proximity detection wearables (Awolusi, Marks, & Hallowell, 2018)

The devices in the construction industry have significantly high levels of accuracy in terms of proximity detection (Figure 18) as well as relatively lower costs – aside from RFID (Figure 19).

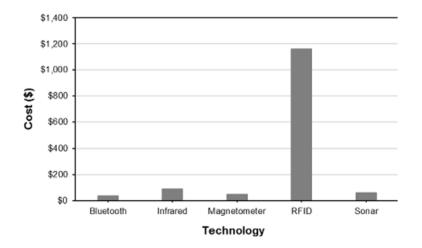
Figure 19: Cost of selected proximity detection wearables (Awolusi, Marks, & Hallowell, 2018)

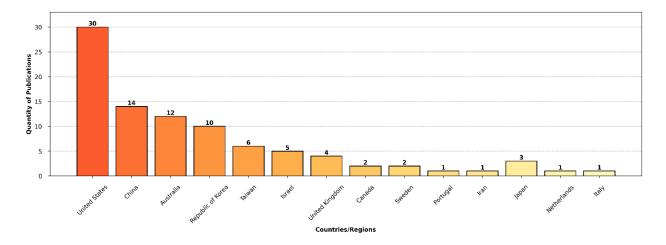
Figure 20: Number of VR/AR publications based on country (Li et al. 2018)

There has been a significant increase in the number of publications regarding the use of Virtual Reality (VR) and Augmented Reality (AR) in the application of construction safety (Figure 20). More specifically, many publications have been produced in the United States regarding VR/AR applications (relative to other countries). Safety planning, training, and education are common applications of VR/AR (Li, Yi, Chi, Wang, & Chan, 2018).

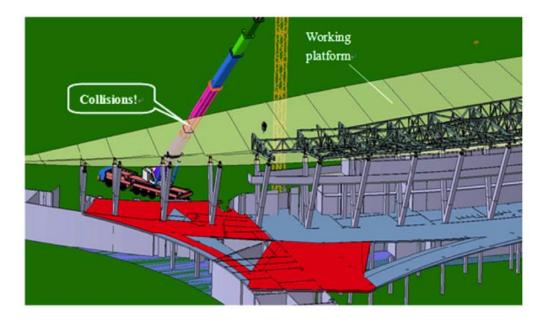
Figure 21: Example VP produced collision detection (Guo, Li, & Li, 2013)

Virtual prototyping allows safety officials to simulate work zones in large-scale construction projects (Figure 21). Many hazards may be misidentified or misjudged during the design phase of a construction project. By virtually prototyping a jobsite prior to execution, it is now possible to identify associated risks and hazards much earlier in the construction process. A framework for this type of technology is shown in Figure 22.

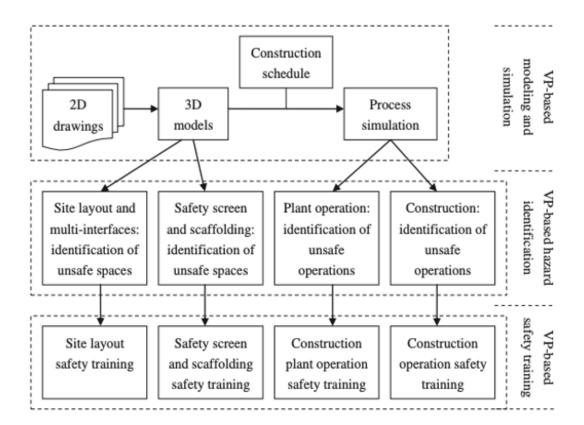
Figure 22: Conceptual framework for VP (Guo, Li, & Li, 2013)

In this framework, models can procure a virtual site that allows for deeper inspections and simulations of jobsite procedures and activities. Potential hazards can either be manually or automatically detected in the simulation, as defined by safety personnel (Guo, Li, & Li, 2013). This type of technical framework is usually limited to the available software that engineers and designers have available. In many cases this software can be costly.

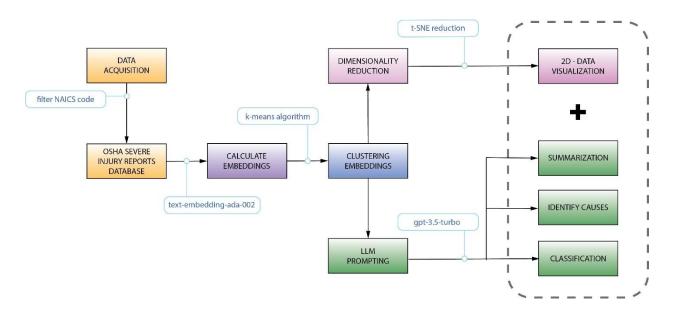
Figure 23: Data processing, visualization, and LLM usage workflow

This section describes the source of data and research methodology. The general workflow of this process, as shown in Figure 23, was created to be reproducible for any further studies. The first step in the analysis is obtaining and processing an appropriate database, with a target of having a full dataset of incidents pertaining to highway construction safety. The project mainly focuses on using language models to derive calculated textual embeddings to be clustered for further analysis – i.e., using LLMs to assist in a data-driven analysis. After the textual embeddings are clustered, these clusters can then be used in LLM prompting to derive human-like generated text that is useful for summarizing, identifying causes, and classification of individual cases. To further visualize the clusters, dimensionality reduction techniques are applied to produce two-dimensional plotting which can be more easily investigated. Figure 23 also highlights the various models and algorithms that were selected to achieve many of the steps. For example, the k-means algorithm was selected for clustering, which was particularly applicable for this general workflow.

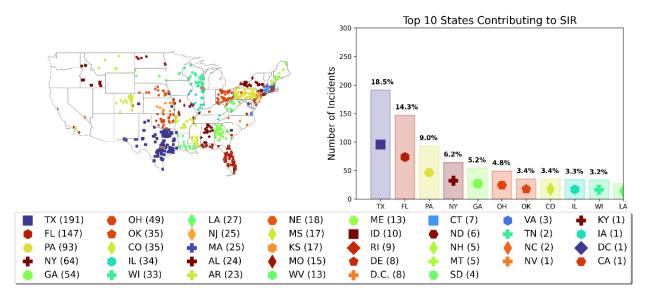
Figure 24: Map of OSHA SIR incidents with highway construction NAICS code

The OSHA SIR database, covering data from 2015 to 2021, has over 70,000 entries considering all the industry codes from the North American Industry Classification System (NAICS). NAICS Code 237310, which refers to Highway, Street, and Bridge Construction was investigated in this task report. This code encompasses a range of activities from conventional paving to airport runaway construction and painting of traffic lines. A total of 1032 accidents with severe injuries were reported to code 237310, making up about 1.5% of the total OSHA SIR database, which ranks the highway construction industry among the top 10 percent of contributors to severe injuries relative to all other industries. Figure 24 demonstrates the distribution of incidents across the United States. Overall, the top three states reporting severe injuries were Texas, Florida, and Pennsylvania with 18.5%, 14.3%, and 9% of contributions, respectively.

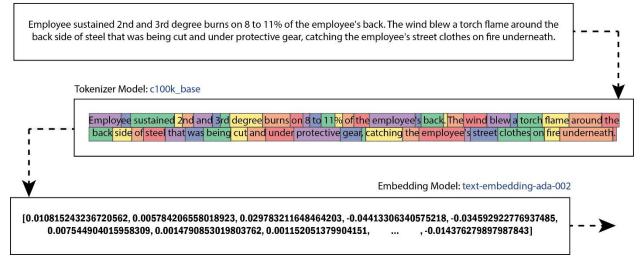
Figure 25: Flowchart - Narrative to embedding vector

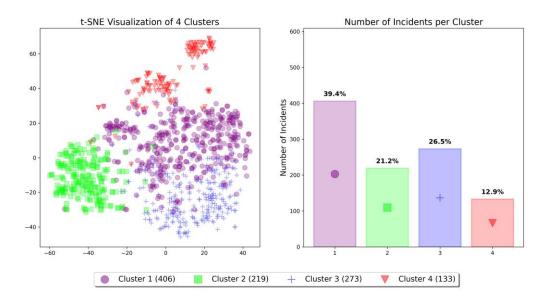
Figure 27: Four clusters identified in road construction incidents (t-SNE)

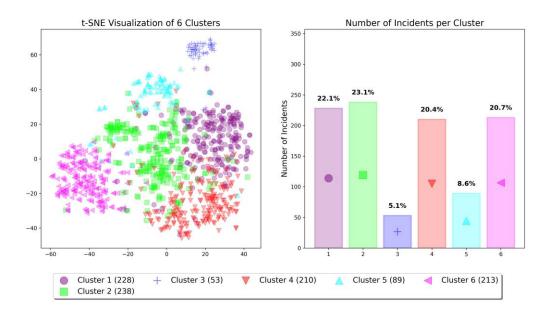
Figure 28: Six clusters identified in road construction incidents (t-SNE)

incidents in these cluster originally had a lot of overlap (based purely on the representative embeddings). Ideally, the six clusters presented in Figure 28 were selected for further analysis. These clusters have distinct regions that they occupy while maintaining minimal overlap, and there appears to be a relatively significant shift in average SSE.

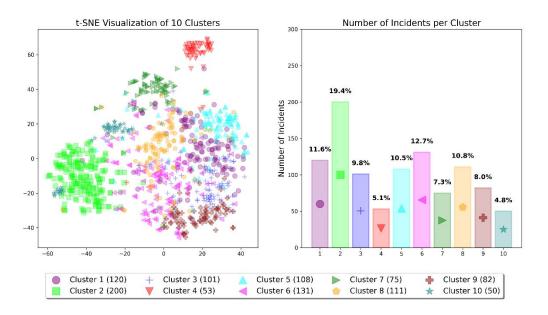
Figure 29: Ten clusters identified in road construction incidents (t-SNE)

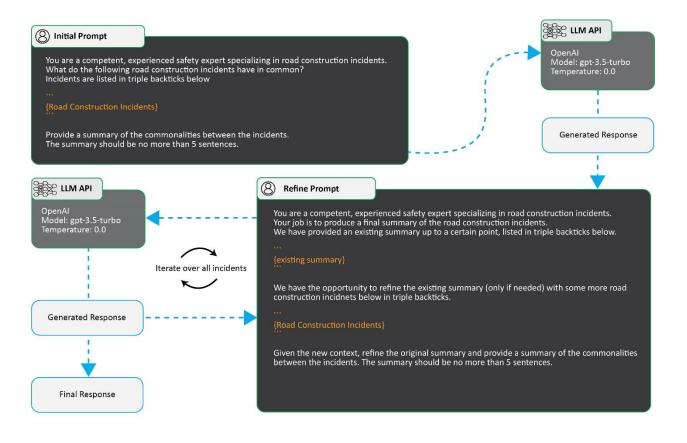
Figure 30: LLM summary prompt template

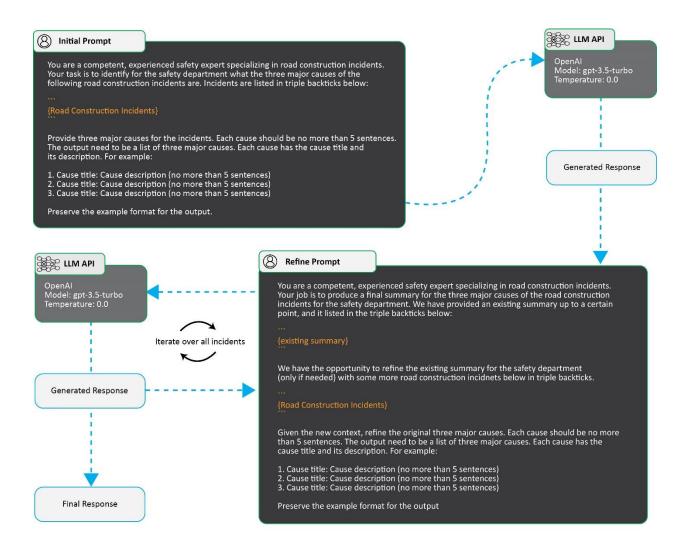
Figure 31: LLM major cause identification prompt template

Similar to the prompt template for LLM summarization, Figure 31 was the final version of the template for identifying the top three major causes within the cluster. The resulting major causes were exemplified for clusters 1-6 in Table 12. While some of the causes pointed out by the LLM are common safety approaches such as "inadequate training or communication", several of the causes are quite specific to the incidents inside the cluster. This type of analysis can help improve safety training to avoid certain incidents, for example, emphasizing how the number of cases regarding the lack of guarding on equipment may be impactful in reducing upper limb injuries.

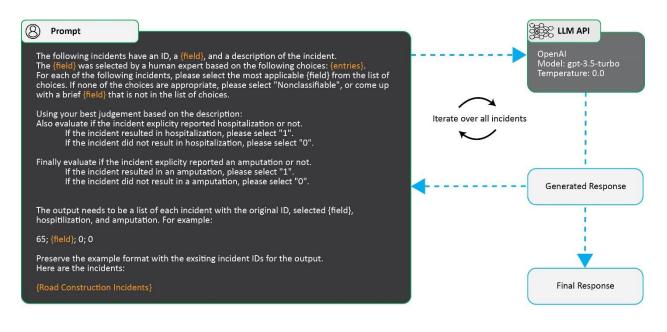
Figure 32: LLM classification prompt template

Both hospitalization and amputation fields were assessed with each of the four major fields, as shown in the prompt template for classification (Figure 32). These queries performed very well in both few-shot and zero-shot modes because they were not dependent on what was previously coded in the field. However, it is interesting to note that they were classified with varying performances when given in the context of different fields. This phenomenon could be partly explained by the probable and statistical randomness of the LLM itself.

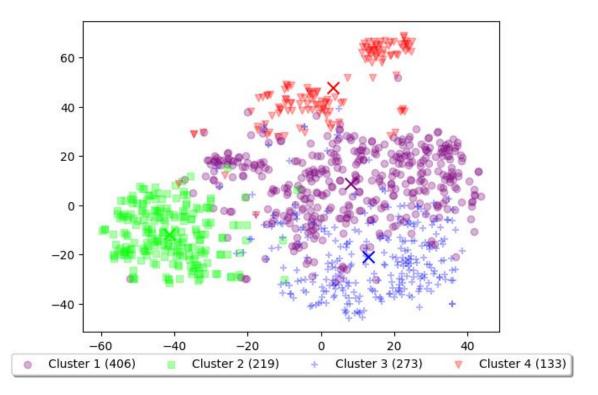
Figure 34: 4 clusters identified in road construction incidents (t-SNE)

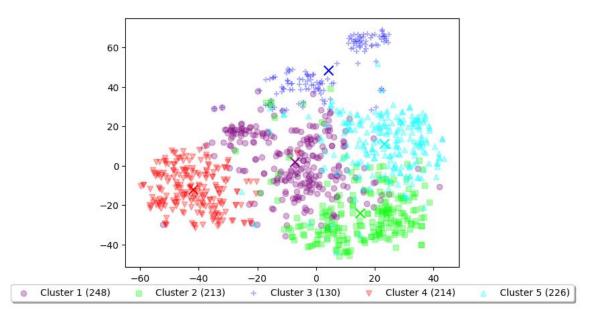
Figure 35: Five clusters identified in road construction incidents (t-SNE)

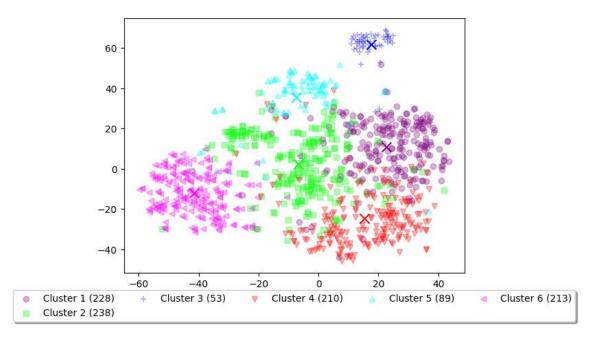
Figure 36: 6 clusters identified in road construction incidents (t-SNE)

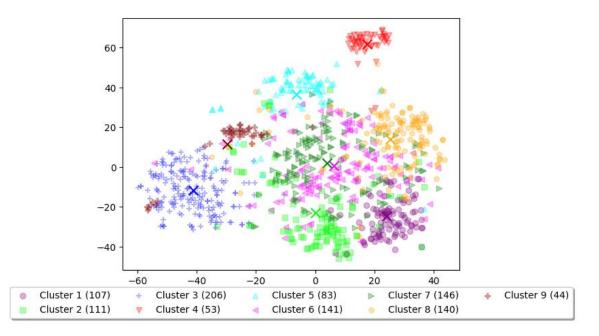
Figure 39: 9 clusters identified in road construction incidents (t-SNE)
