Preliminary Evaluation of Pavement Surface Distresses Related to Pavement Markings

Lucio Salles, Lev Khazanovich
IRISE ANNUAL MEETING
MAY 17, 2023

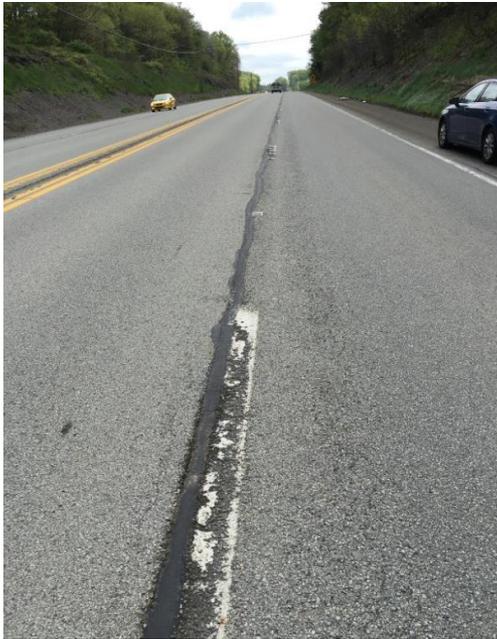
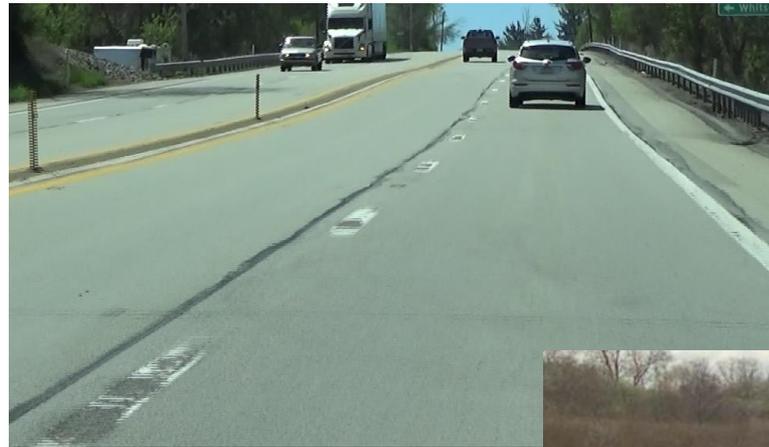
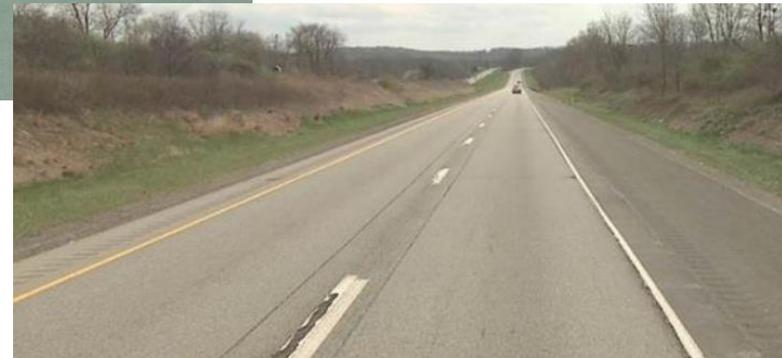
- ❑ Reports of pavement distresses, such as cracking and raveling, under or along pavement markings

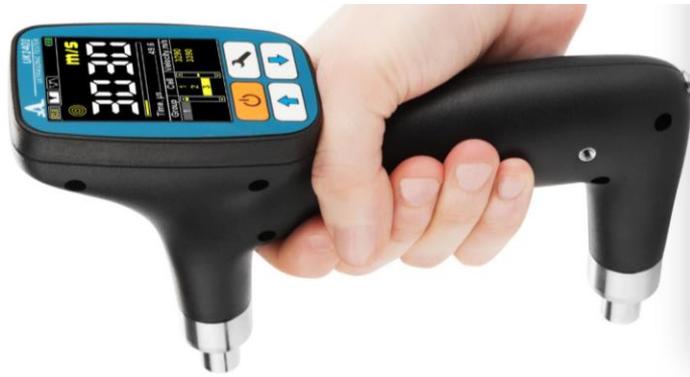
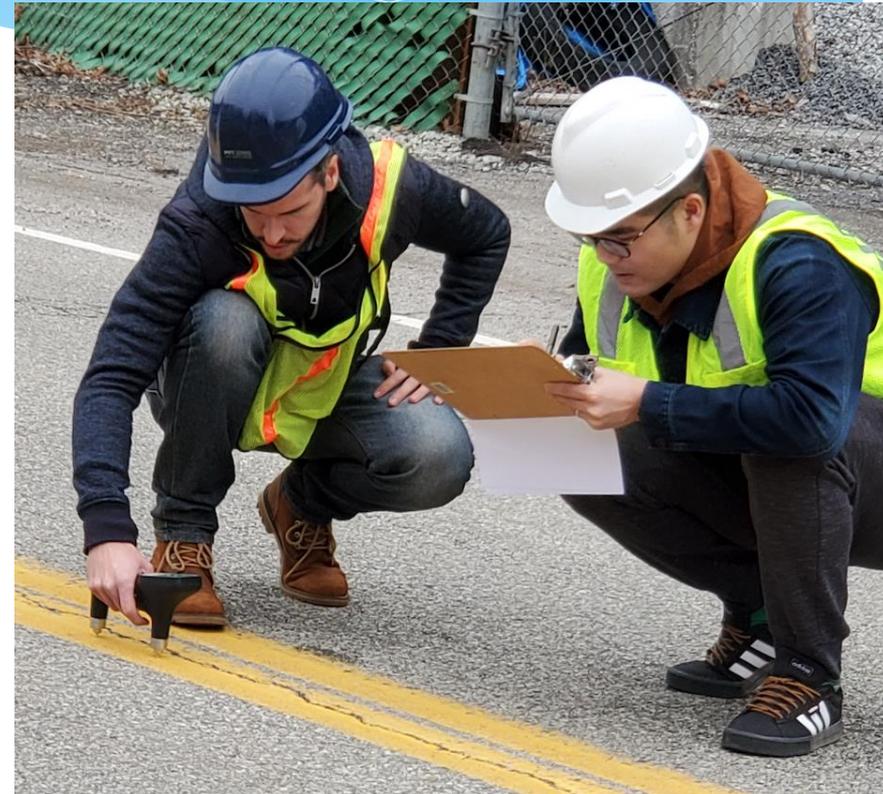
- ❑ Ultrasonic Testing
- ❑ Measure Pulse Velocity
- ❑ Related to stiffness, density

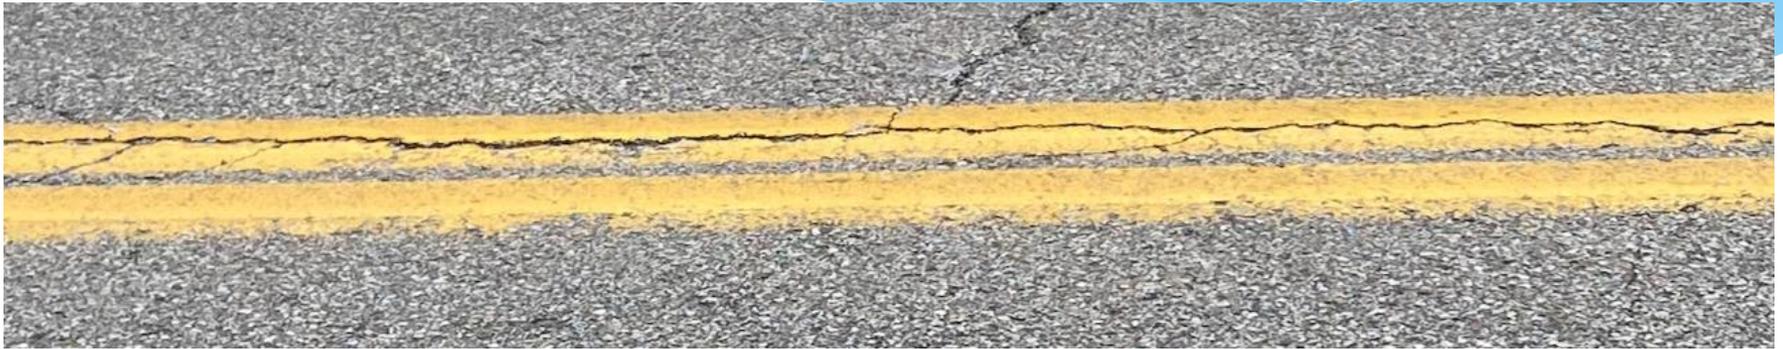
Deteriorated Joint

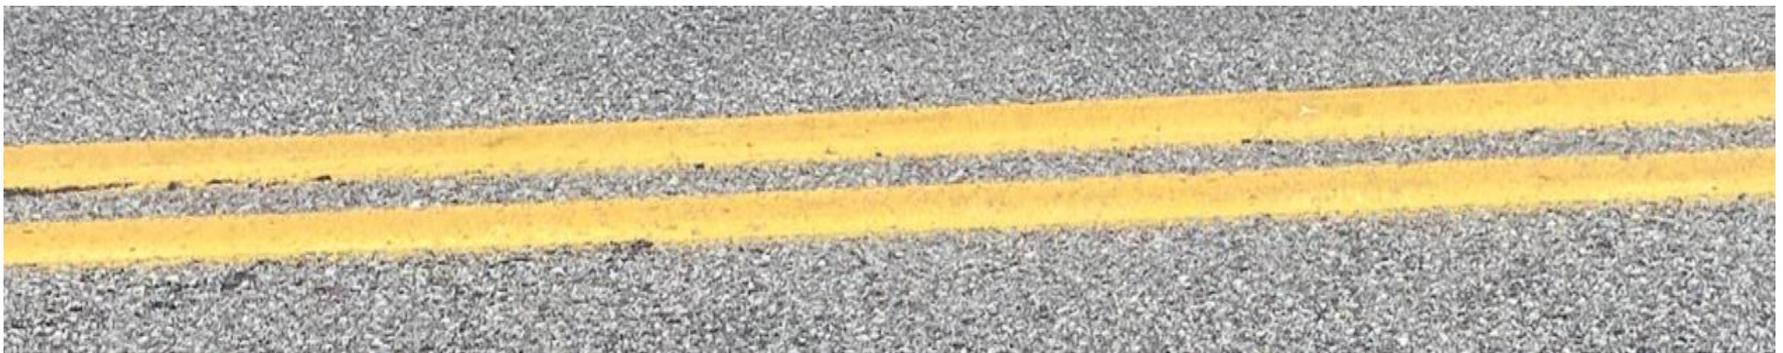
Intact Joint

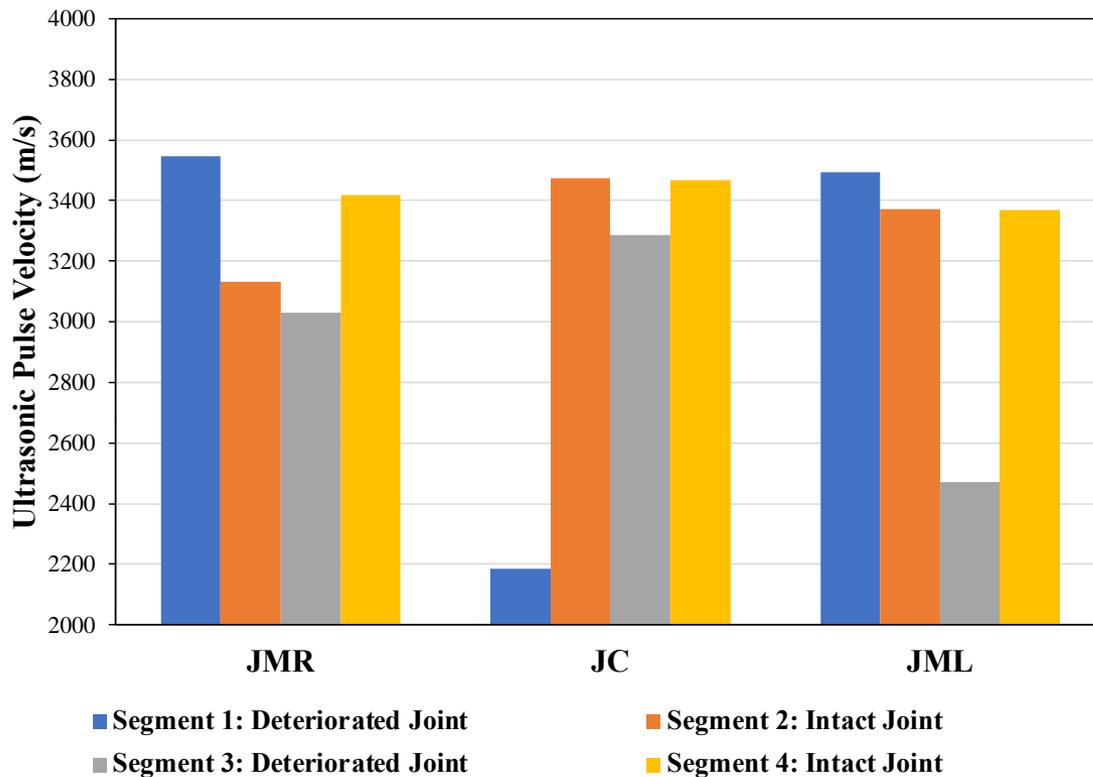
- Joint Marking Left (JML)
- Joint Center (JC)
- Joint Marking Right (JMR)
