# Improving Bridge Assessment through integration on Visual Inspection and Non-destruction **Evaluation Data**

#### Spring Transportation Forum | Improving Bridge Assessment via Integrating Visual Inspection and NDE Data 3

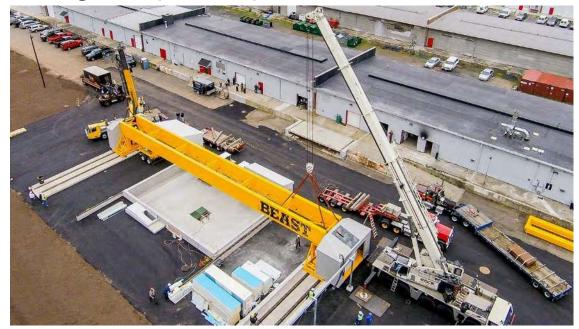
Bridge Evaluation and Accelerated Structural Testing Lab (BEAST):

- Full-scale Bridge Systems
- Accelerated Deterioration
- Speed up 30 times
- > NDE Data Collected from the BEAST:
  - Electrical Resistance (ER)
  - Ultrasonic Surface Wave (USW)
  - Ground Penetrating Radar (GPR)
  - Half Cell Potential (HCP)

- > UAV Data Collected from the BEAST:
  - HD Images (UAV/Hand-held)
  - Infrared Images (UAV/Hand-held)

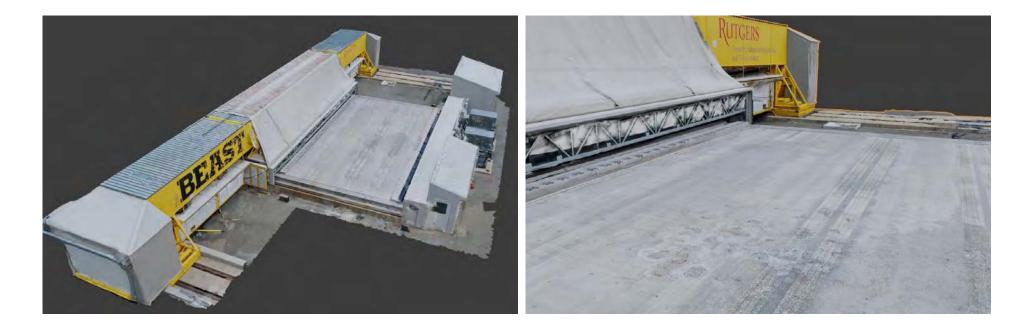
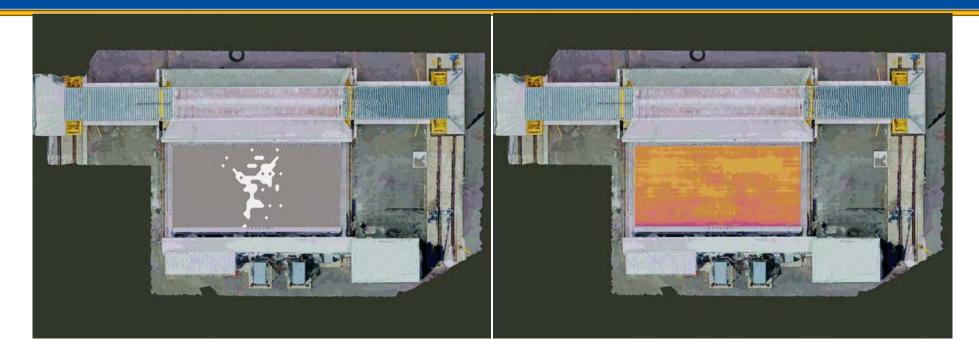
To achieve better visualization, a 3D model of the BEAST has been developed as follows:

- Application:
  - □ Virtual bridge inspection
  - □ Bridge inspection training
  - Better post data interpretation and visualization
