Performance, Analysis, and Repair of Ultrathin and Thin Whitetopping at Minnesota Road Research Facility

Julie M. Vandenbossche and Aaron J. Fagerness

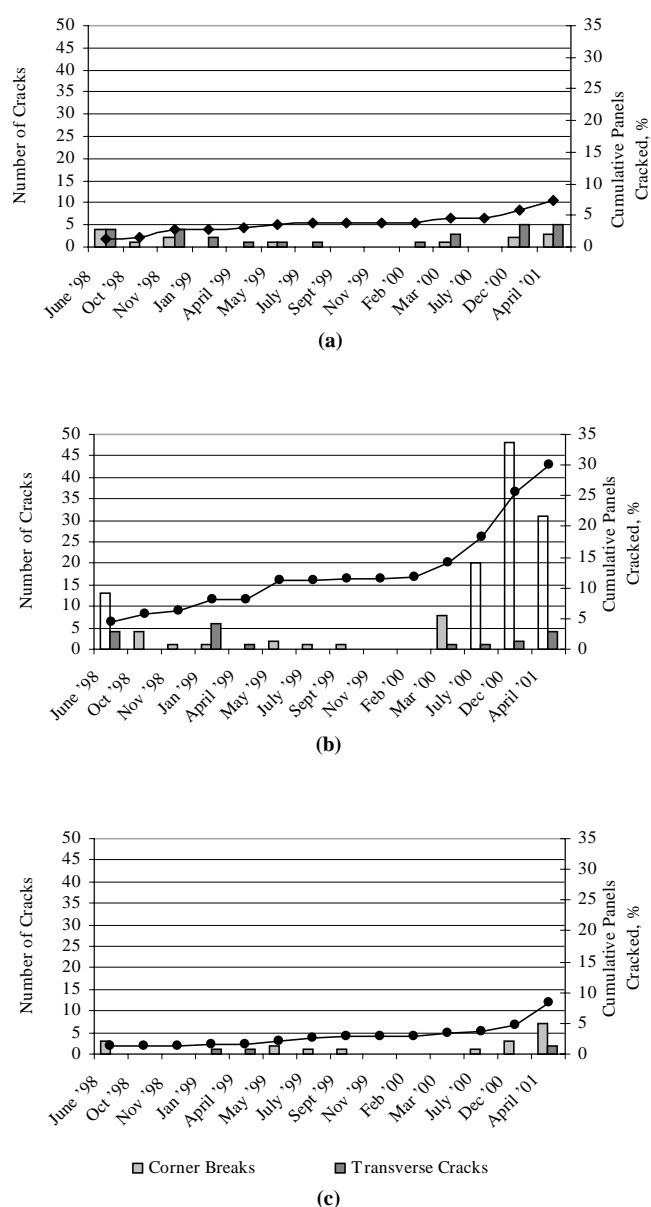
Figure 1*a* summarizes the distress data for the 102-mm (4-in.) over-lay with 1.2- × 1.2-m (4- × 4-ft) panels. Since the time of con-struction, 7% of the panels have exhibited cracking: 34% of the observed distresses are corner breaks, and the remaining 66% are transverse cracks. Most of the corner breaks occurred along the inside longitudinal joint because of its location directly in the in-side wheelpath (see Figure 2*c*). Transverse cracks often occur in the outside wheelpath near a transverse joint (Figure 2*a*). At times, these transverse cracks were intercepted by corner breaks that ini-tiated at the intersection of the wheelpath and the transverse joint (Figure 2*b*). Of the cracking in this section, 73% occurred in the driving lane.

Figure 1*b* summarizes the distress data for the 76-mm (3-in.) overlay with 1.2- × 1.2-m (4- × 4-ft) panels. This test section developed a greater number of corner breaks and transverse cracks than the other sections, with 30% of the panels exhibiting distress after 4.7 million ESALs: 83% of the distressed panels are located in the driving lane, 87% of the observed distresses are corner breaks, and the remaining

Figure 1*c* summarizes the distress for the 76-mm (3-in.) overlay with 1.5- × 1.8-m (5- × 6-ft) panels. The performance of this test section to date has been comparable with that of the 102-mm (4-in.) overlay with 1.2- × 1.2-m (4- × 4-ft) panels, which is significantly better than the other 76-mm (3-in.) overlay with 1.2- × 1.2-m panels. Only 8% of the panels in the 76-mm overlay have developed cracks, of which

FIGURE 1   Distresses occurring on (*a*) 102-mm overlay with 1.2- 1.2-m panels, (*b*) 76-mm overlay with 1.2- 1.2-m panels, and (*c*) 76-mm overlay with 1.5- 1.8-m panels.

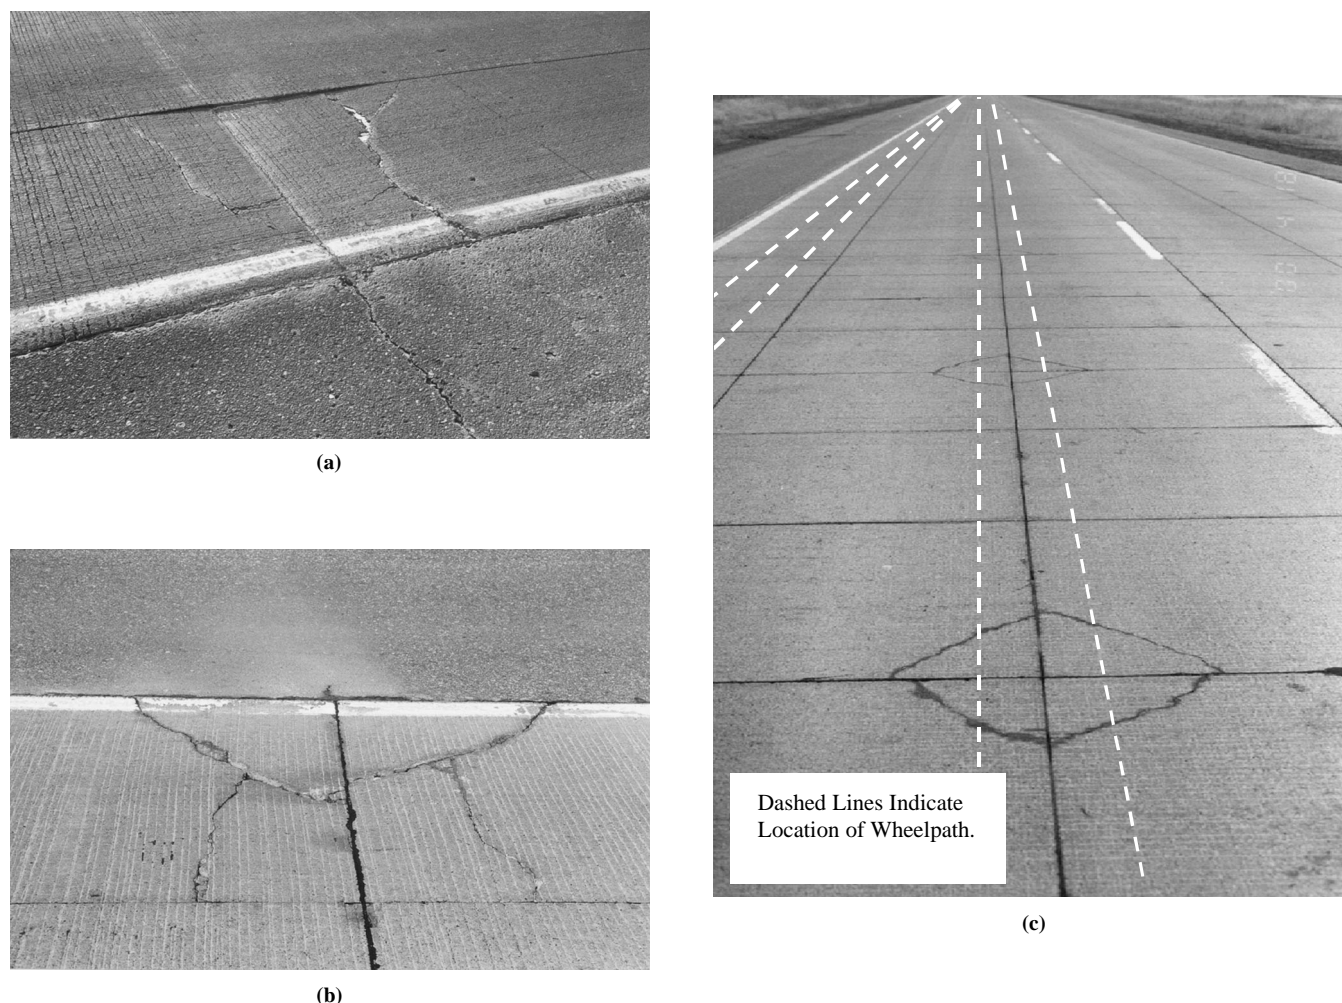
FIGURE 2   Ultrathin whitetopping with 1.2-   1.2-m panels: (a) load-related transverse cracks, (b) load-related corner breaks and transverse cracks, and (c) corner cracks in wheelpath.

The amount of cracking and the cracking pattern that occurred in each section are directly influenced by the joint layout. The longitudinal joint of a 1.2- × 1.2-m (4- × 4-ft) joint layout is located in the inside wheelpath. This location resulted in corner cracking for both the 76-

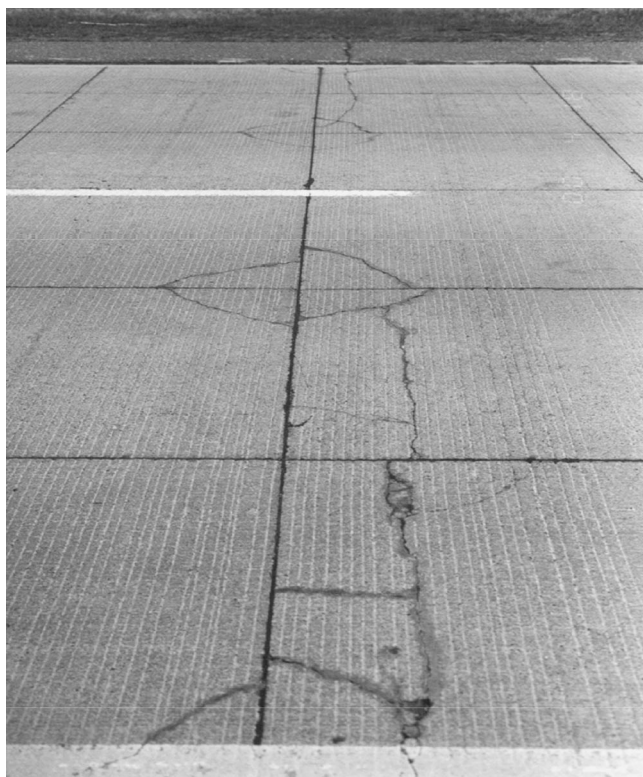
FIGURE 3   Reflective cracking in ultrathin whitetopping.

Many of the transverse cracks appearing in the overlays are a result of previously existing temperature cracks in the asphalt that reflect up through the concrete. Reflective cracking is a function of both uniform temperature- and load-related stresses. The thermal contraction of the asphalt in the winter creates a stress concentration at the bottom of the concrete in the region near the tip of the crack in the asphalt. The magnitude of the tensile stress at the bottom of the concrete is then increased as a result of vehicle loads, thereby causing the crack in the underlying asphalt to propagate up through the concrete overlay.

The 152-mm (6-in.) overlays did not experience reflective cracking: 32% of the preexisting cracks in the asphalt propagated up through the overlay in the 76-mm section with 1.5- × 1.8-m (5- × 6-ft) panels. In the 76-mm section with 1.2- × 1.2-m (4- × 4-ft) panels, 56% of the preexisting cracks reflected through the overlay. In the 102-mm (4-in.) overlay with 1.2- × 1.2-m panels, 50% of the cracks reflected up through the concrete. All but two of the reflective cracks developed during the spring and winter. It is possible that these two cracks also initiated during the winter or spring but were not noticed until the following summer. Reflective cracking typically occurred earlier in the driving lane than in the passing lane, indicating that the volume of traffic accumulated affects the development of reflective cracks.

Panel size and overlay thickness also affect the development of reflective cracking. The section with the shortest joint spacing and the thinnest overlay (76-mm overlay with 1.2- × 1.2-m panel spacing) experienced the highest percentage of cracks reflecting through the overlay, whereas no cracking occurred in the 152-mm (6-in.) overlays. The 102-mm (4-in.) overlay with the same panel size (1.2 × 1.2 m) had a slightly lower percentage, but this difference might not be statistically significant. The 76-mm section with larger panels (1.5 × 1.8 m) had the lowest percentage of thermal cracks propagating through the overlay among the three ultrathin test sections. As previously discussed, the load-related stress is higher in the ultrathin overlays with 1.2- × 1.2-m panels because the longitudinal joint lies in the wheelpath. The load-related stresses coupled with thermal stresses generated during the colder months of the year work together to promote the reflection of cracks from the asphalt into the overlay.

Several repairs contained reflective cracks in the overlay that were near the sawed transverse joint. After milling, it was revealed that a crack would still propagate down from the joint into the asphalt even when a full-depth transverse reflective crack was near the joint. The reflective crack tended to be the working crack, so the new joint made in each repair was sawed over the reflective crack. Small strips of roofing paper were placed over these cracks and stapled to the asphalt as a bond breaker. This treatment was necessary to prevent reflective cracking in the areas where the meander of the crack would not follow the straight joint sawed into the repair. Roofing paper was used in lieu of duct tape if the cracks tended to meander significantly because the pieces of roofing paper could be tailored to fit the shape of the crack. Duct tape was placed as a bond breaker over the straight cracks in the asphalt that propagated down from the joints sawed into the overlay during initial construction. The duct tape was also stapled to the asphalt to prevent it from moving while the concrete was being placed.

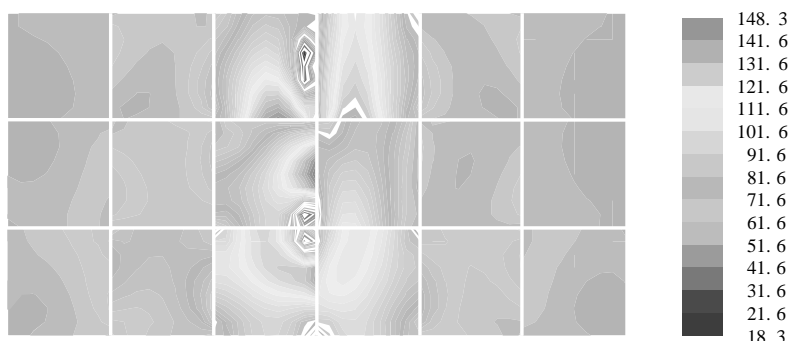
ISLAB2000 was also used to model the Mn/ROAD test section containing a 76-mm (3-in.) overlay with 1.2- × 1.2-m (4- × 4-ft) panels loaded with a 102-kN (23-kip) truck axle and a 0.44°C/cm (2°F/in.) temperature gradient. The principal stress contour plot was generated for the top of the slab and is provided in Figure 4; the plot indicates that corner breaks would develop in the inside wheelpath along the longitudinal joint and that transverse cracking would develop in the outside wheelpath near the transverse joint. This theoretical cracking pattern matches the actual cracking pattern that developed for this test section at Mn/ROAD. The high tensile stresses that develop along the longitudinal joint in the inside wheelpath emphasize the need to consider the location of the wheelpath with respect to the longitudinal joints when the optimum panel size is determined. Although a 0.6- × 0.6-m (2- × 2-ft) joint layout was not included in this study, both the outside and inside wheelpaths lie directly on the longitudinal joints,

FIGURE 4   Theoretical stresses due to 102-kN axle load and 0.44°C/cm temperature gradient (76-mm overlay with 1.2-   1.2-m joint spacing).

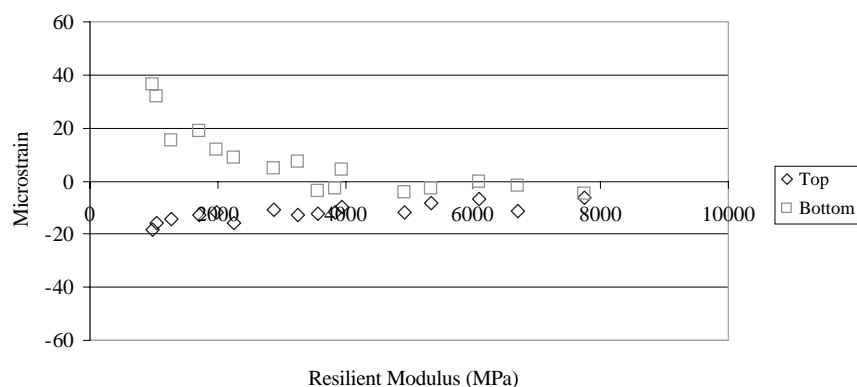
The stiffness of the asphalt and the quality of the bond between the concrete overlay and the asphalt also have a significant effect on the performance of the overlay. Temperatures ranging between 38°C (100°F) and −15°C (4°F) have been measured using thermocouples embedded in the middle of the asphalt layer during construction. Cores were taken from the asphalt pavement after each lift was placed and used to develop the relationship between resilient modulus and temperature. Using this relationship, the resilient moduli of the asphalt at these two temperatures are 1,160 MPa (168,000 psi) and 10,900 MPa (1,580,000 psi), respectively. When the temperature is higher, the asphalt below the concrete provides less support. The overlay must then bear a larger portion of the load, resulting in higher stresses. The relationship between changes in strain with changes in resilient modulus was characterized for the 76-mm overlay with 1.2- × 1.2-m panels by applying a 40-kN (9-kip) falling-weight deflectometer load in the outer wheelpath adjacent to the transverse joint when the asphalt was at different temperatures. The strains were measured at the bottom of the concrete overlay and 25 mm (1 in.) from the top of the concrete. The results are provided in Figure 5, which shows that strain increases significantly when the resilient modulus is below 3,000 MPa (435,000 psi). The strain is close to zero when the resilient modulus

is around 4,000 MPa (580,000 psi), and the entire concrete overlay is in compression when the resilient modulus is above 4,000 MPa (580,000 psi). The resilient modulus is 4,000 MPa (580,000 psi) when the asphalt temperature is 6°C (43°F) and 3,000 MPa (435,000 psi) when the temperature is 11°C (51°F). The average monthly temperature is greater than 6°C (43°F) for 7 months of the year in Minnesota and greater than 11°C (51°F) for 5 months of the year (6). Therefore, compressive stresses will be generated at the bottom of the overlay under an applied load the majority of the time for 4 months of the year. The bottom of the overlay will be in tension under an applied load the majority of the time for 5 months of the year. The data in Figure 5 demonstrate the importance of considering seasonal effects when the design life of ultrathin whitetopping is determined.

FIGURE 5   Strain directly under 40-kN falling-weight deflectometer load applied in wheelpath adjacent to transverse joint on 76-mm overlay with 1.5-   1.8-m panels.

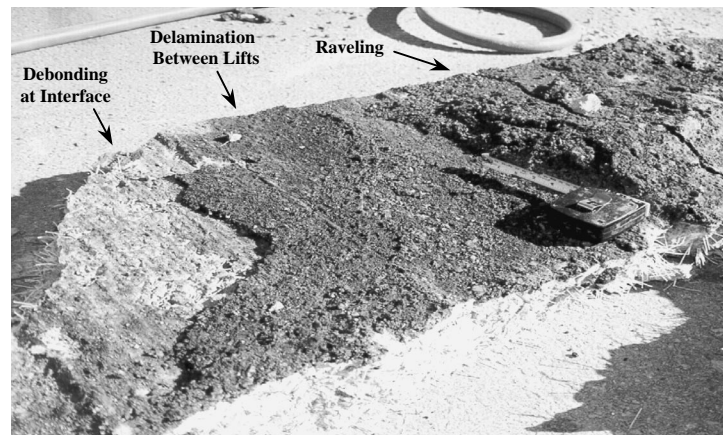
Over time, the combined stiffness of the overlay and the asphalt cross section can decrease. There are three means by which the stiffness of this monolithic section can be reduced: the overlay debonds at the interface between the asphalt and concrete, delamination occurs between lifts within the asphalt, or the asphalt ravels. This decrease in stiffness also leads to less support from the underlying pavement, higher stresses in the overlay, and potentially cracking. The mode of deterioration will dictate the depth of repair required if cracking does occur. These three modes of deterioration are shown in Figure 6, in which the bottom portion of a panel from an ultrathin whitetopping section is shown after it had been removed with a backhoe. The photograph was from a section of ultrathin whitetopping being repaired on US-169 near Mankato, Minnesota, in October 1998.

FIGURE 6   Three different modes of debonding between asphalt and concrete overlay.

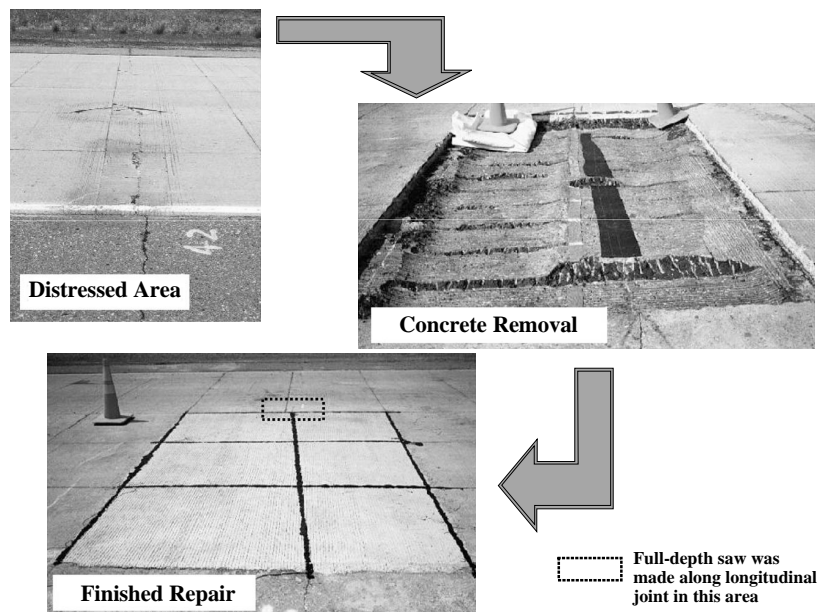
FIGURE 7   Repairing reflective cracks in ultrathin whitetopping.

Repairing areas with corner breaks and transverse cracking consisted of removing the distressed panels using a milling machine and chisel-hammers, as described above, and placing concrete back into the repair area. Repairing panels with reflective cracks presented additional difficulties. Several techniques were implemented to deter the reoccurrence of reflective cracking. The first approach was to place a bond-breaking material over the cracks in the asphalt to prevent cracks from reflecting up into the repaired panel. Two different types of debonding materials were tested, duct tape and roofing paper.

Figures 7 and 8 show examples of typical repairs performed on the ultrathin whitetopping sections at Mn/ROAD.

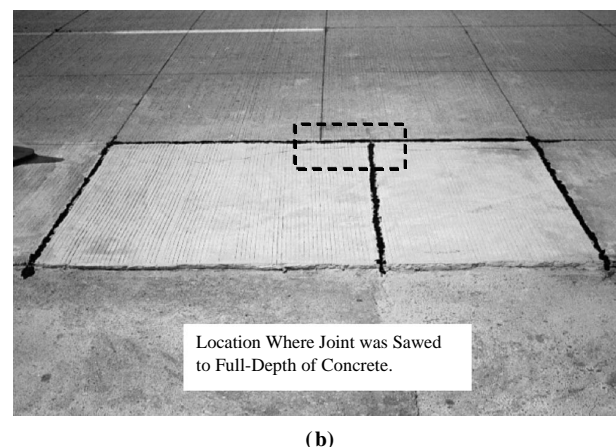
(a)

FIGURE 8   Repairs on Mn/ROAD: (*a*) joint sawed directly over existing crack in asphalt and (*b*) longitudinal joint sawed to depth of overlay to prevent cracking.
