FINAL REPORT

IRISE-22-P21-02-01 • SEPTEMBER 2022

Preliminary Evaluation of Pavement Surface Distresses Related to Pavement Markings

PITT | IRISE

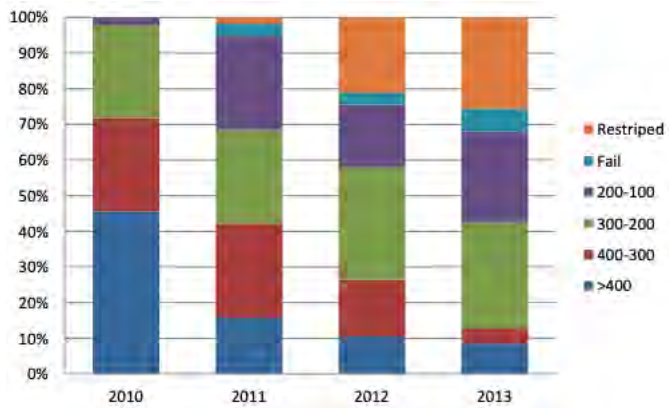
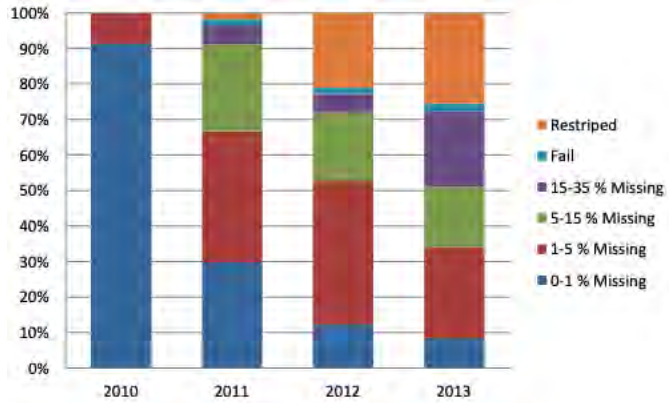
Figure 1: Field marking deterioration as measured by (a) retroreflectivity (mdc/m^2/lux) and (b) presence [7]

Horizontal pavement markings provide guidance and visibility for drivers, especially during nighttime, which has a direct impact on road safety. Pavement markings are used so that a driver does not need to divert their attention from the road, encouraging traffic safety and flow [1]. Pavement marking performance is usually quantified based on two parameters: durability and retroreflectivity. Durability is usually evaluated by visual surveys where a trained evaluator gives a rating for a marking based on the percentage of marking lost. The evaluation is very subjective and varies from one survey to another. Another way to assess marking durability is to test the bond between marking and pavement surface as well as resistance to different traffic levels. Retroreflectivity is a phenomenon in which a portion of the vehicle's lights are reflected back into the driver's line of sight after hitting the marking. Several studies have shown an increase in driver visibility and interpretation capacity at night when exposed to markings and signs with higher retroreflectivity levels [2]–[5] significantly improving driving skills [6]. As can be seen in Figure *1* from a study conducted in Illinois with the evaluation of several marking materials in different surfaces, both retroreflectivity and durability (evaluated as marking presence) deteriorate in short periods [7].

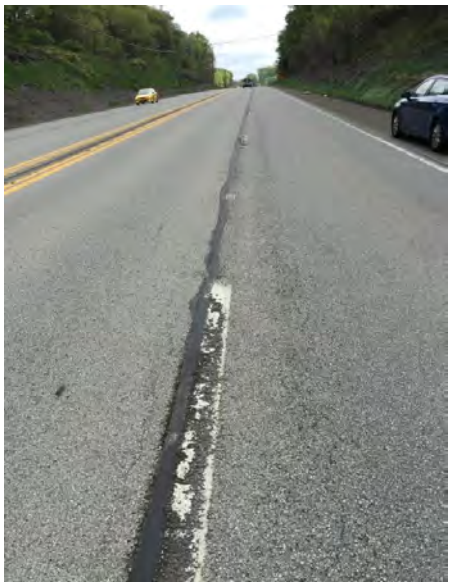
Based on a 2018 internal memorandum, District 10 has been observing distresses like surface delamination (Figure 1) and potholes (Figure 11) occurring mostly on the white skip markings on multi-lane highways. According to Michael J. Shanshala, former Maintenance Services Engineer for District 10, markings perform well in the initial three to five years after marking placement. After this period, the markings start to delaminate, exposing a dark and raveling asphalt and within two years after the initial distress, delamination becomes more severe with aggregate popouts (Figure 12) around the line migrating to potholes.

Figure 10: Surface delamination on US 422 skip line

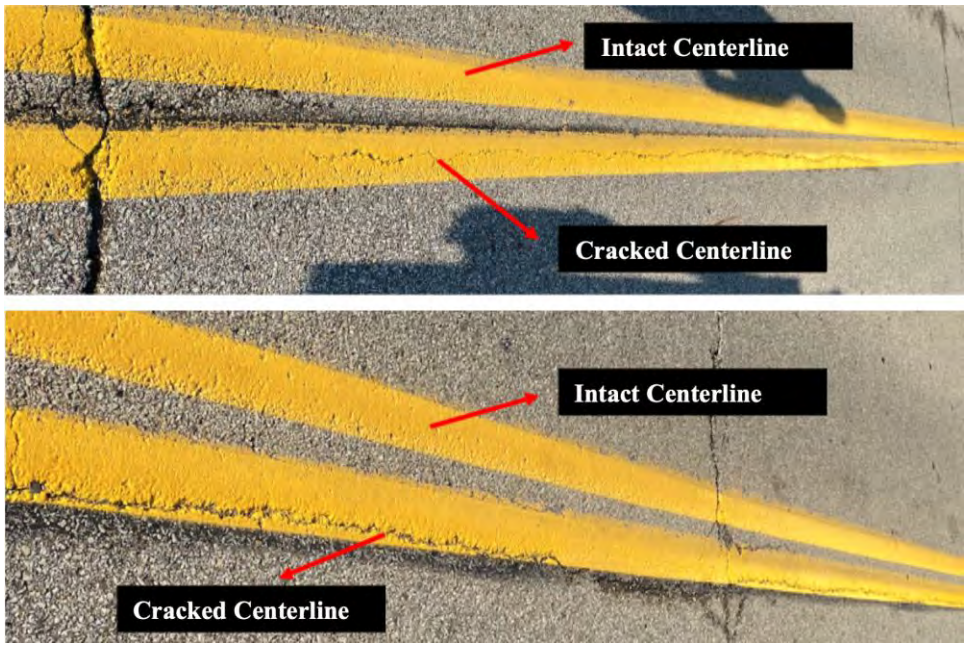
The pavement in this section presents several cracking distresses that connect to the cracking at the longitudinal joint – centerline marking (Figure 16). There is no indication that the markings are the cause of such distresses. Interestingly, the double continuous line in the lane center contains a longitudinal crack in only the line closest to the longitudinal joint. The other line is intact as seen in Figure 17.

Figure 17: Examples of longitudinal crack in only one of the centerlines

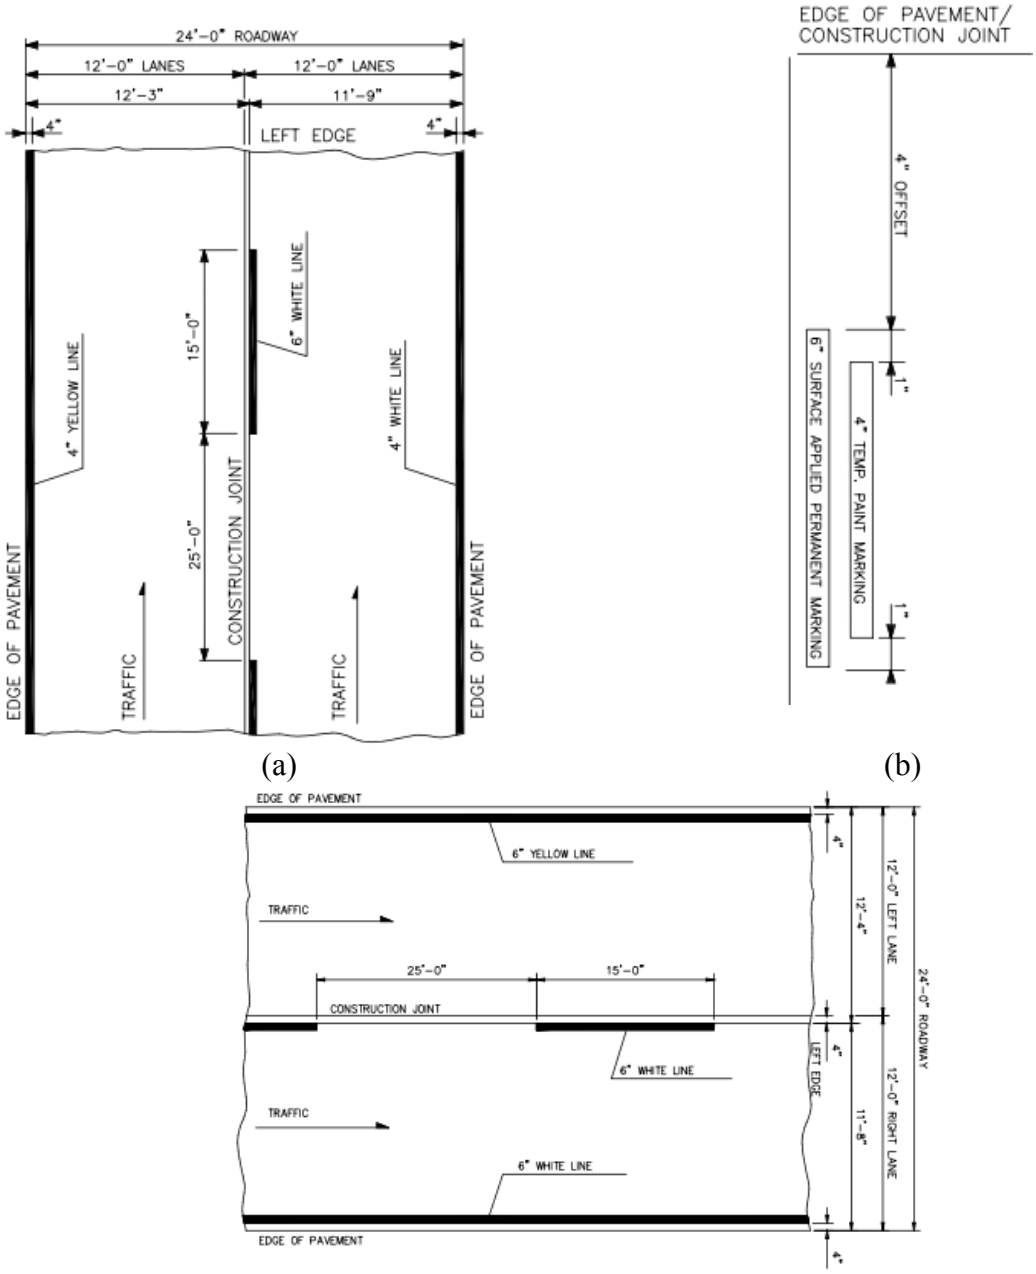
Figure 24: Turnpike Commission standards regarding offset of centerline marking placement from longitudinal joint in (a) 2011 [54], (b) 2012 [55], and (c) 2015 [56]

The Turnpike Commission initially reported anecdotal issues with distresses around pavement markings. However, upon further investigation, Turnpike informed that those issues were resolved by altering the standards concerning the location of the markings in relation to the longitudinal joint. Standards from 2011 (Figure 24a) show that there was not a recommended offset between the centerline (white marking) and the construction joint [54]. In 2012, an updated standard [55] shows a 4 in. offset for the marking placement (Figure 24b). The 2015 standard [56] which is used currently for permanent markings emphasizes this offset with an additional drawing. The Turnpike Commission informed that since the change in 2012 there were less issues with the durability of pavement markings and the pavement underneath it.

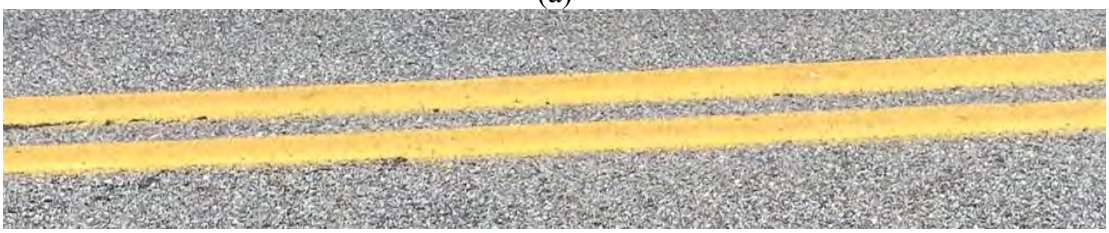
Several segments of each section were tested. The segments were selected based on the level of visible deterioration of the longitudinal joint. Segments presenting surface cracks at the longitudinal joint were classified as “deteriorated” whereas segments without surface distress were classified as “intact”. Figure 26 shows this classification in two segments from Section 1. It should be noted that even if there are no clear distresses on the pavement surface, the pavement structural integrity may still be affected by potential underlying distresses (for example bottom-up cracking).

Figure 26: Segments presenting (a) deteriorated and (b) intact longitudinal joint area in Section 1

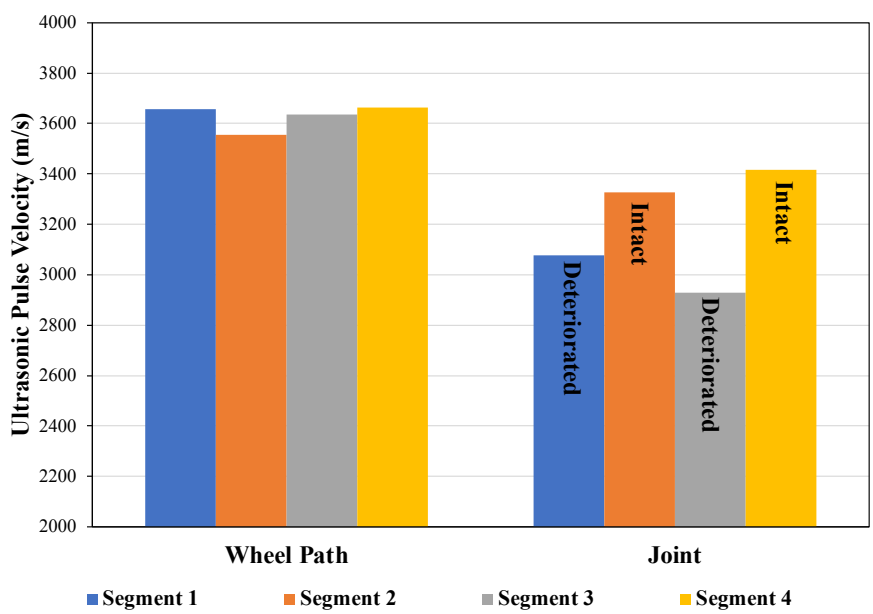
Figure 28: Ultrasonic pulse velocity at wheel path and longitudinal joint in Section 1

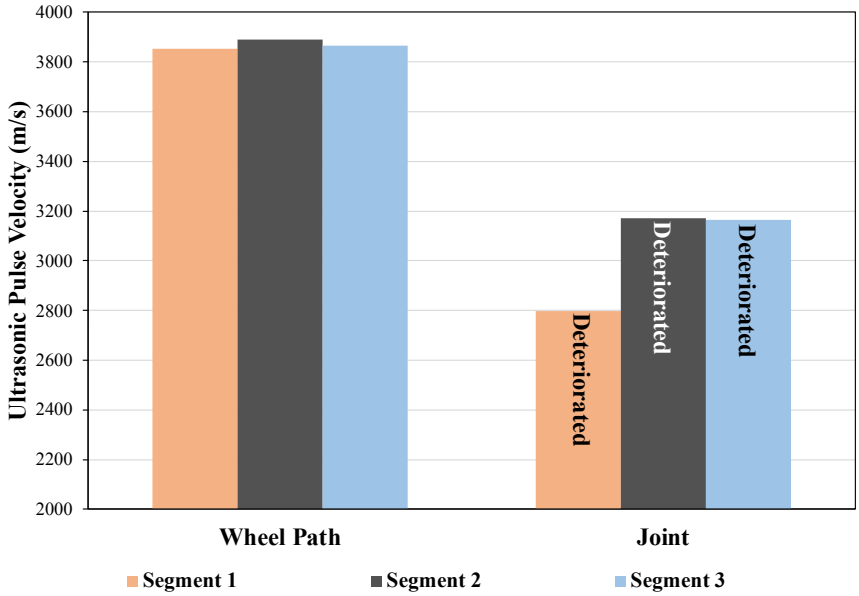
Similar results were obtained from Section 2 (Figure 29) where the wheel path presents high, uniform pulse velocity with an average of 3870 m/s. The longitudinal joint was so heavily deteriorated that no intact segments could be scanned for this section. This longitudinal joint showed a much lower pulse velocity than the lane center with an average of only 3044 m/s.

Figure 29: Ultrasonic pulse velocity at wheel path and longitudinal joint in Section 2

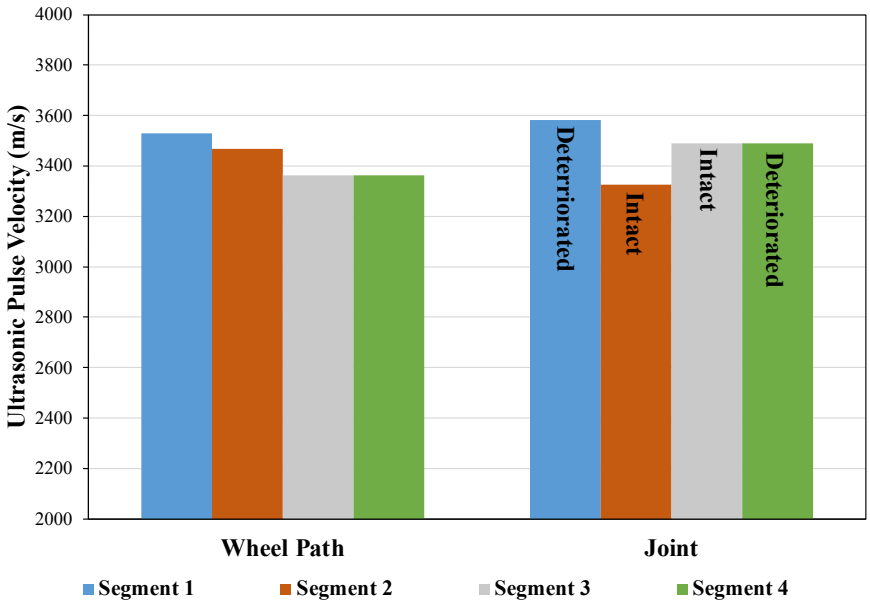
Section 3 differed from the previous sections by showing similar pulse velocity between the wheel path and the longitudinal joint with averages of 3479 and 3498 m/s, respectively. This can indicate that the construction of the longitudinal joint for this section was more successful in achieving similar density levels when compared to the center of the lane. However, from all the tested sections, Section 3 segments present significantly more deterioration at the wheel path (Figure 30) even when the longitudinal joint area seemed intact. The presence of distress in the wheel path, as seen in Figure 31 can also help explain the lower pulse velocity in comparison with the other Sections although comparison between sections can be misleading.

Figure 30: Ultrasonic pulse velocity at wheel path and longitudinal joint in Section 3

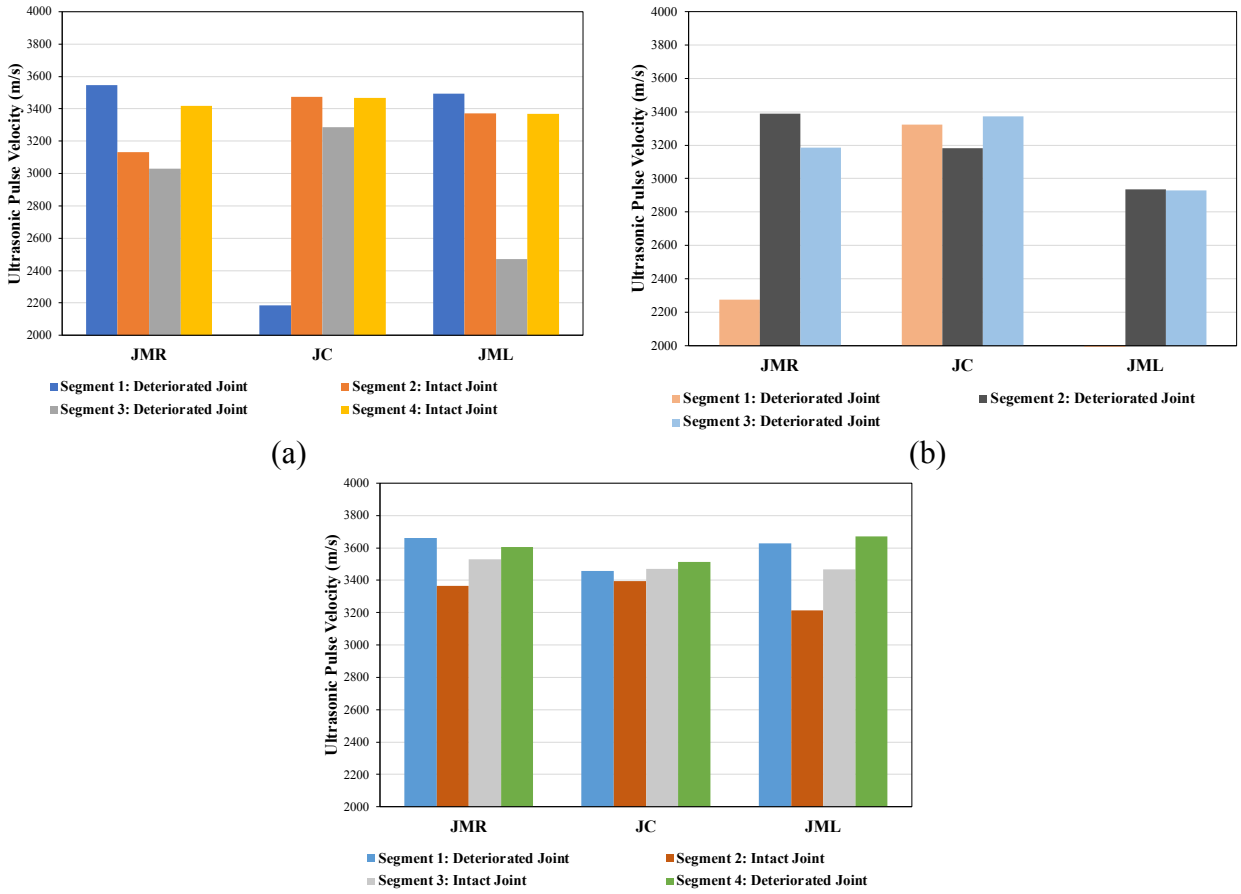
To evaluate the effect of markings on the ultrasonic pulse velocity, measurements at the longitudinal joint on top of the markings (joint marking right - JMR and joint marking left - JML) and between markings (joint center - JC) were analysed. Figure 32 presents the results for the three sections. As can be seen in the figures, results are inconclusive. There is no indication that measurements on top of the marking produces higher or lower pulse velocity.

Overall results indicate that pulse velocity is more affected by the proximity to the longitudinal joint regardless of the presence of pavement markings. An extra set of measurements was performed in segment 3 of Section 2 in which the ultrasonic device was positioned with an offset of 10 cm from the outer centerline marking. Results (illustrated in Figure 33) show that pulse velocity and potentially asphalt concrete density increases significantly right outside of the joint. This could help explain the success in avoiding premature marking deterioration by the Turnpike Commission when changes in standards for marking placement in relation to longitudinal joints were put in place.

Figure 32: Ultrasonic pulse velocity at the joint for (a) Section 1, (b) Section 2, and (c) Section 3

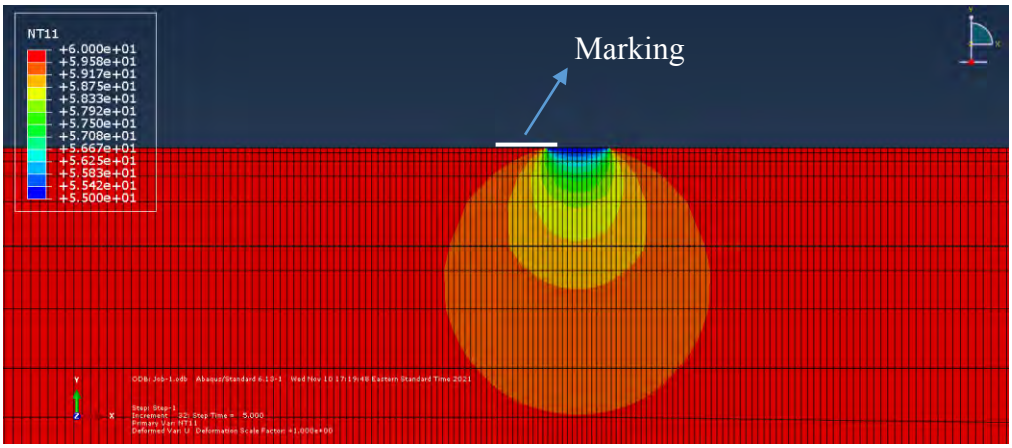
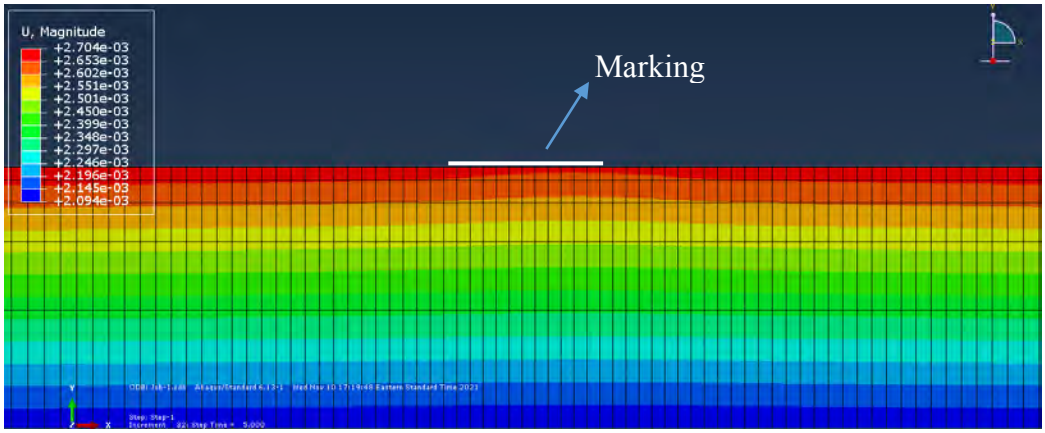
Figure 36: (a) Temperature distribution and (b) displacement in vertical direction

The temperature distribution, vertical displacement, stresses in transverse (x direction) and vertical (y direction) directions cause by the temperature differential are shown in Figure *36* and Figure 37. The temperature distribution in Figure *36*a shows a decreasing gradient, with a lower temperature closer to the marking area. Figure *36*b shows the surface temperature differential effect on deformation decreases with an increase of asphalt depth. These results are as expected based on previous hypotheses outlined in this report.

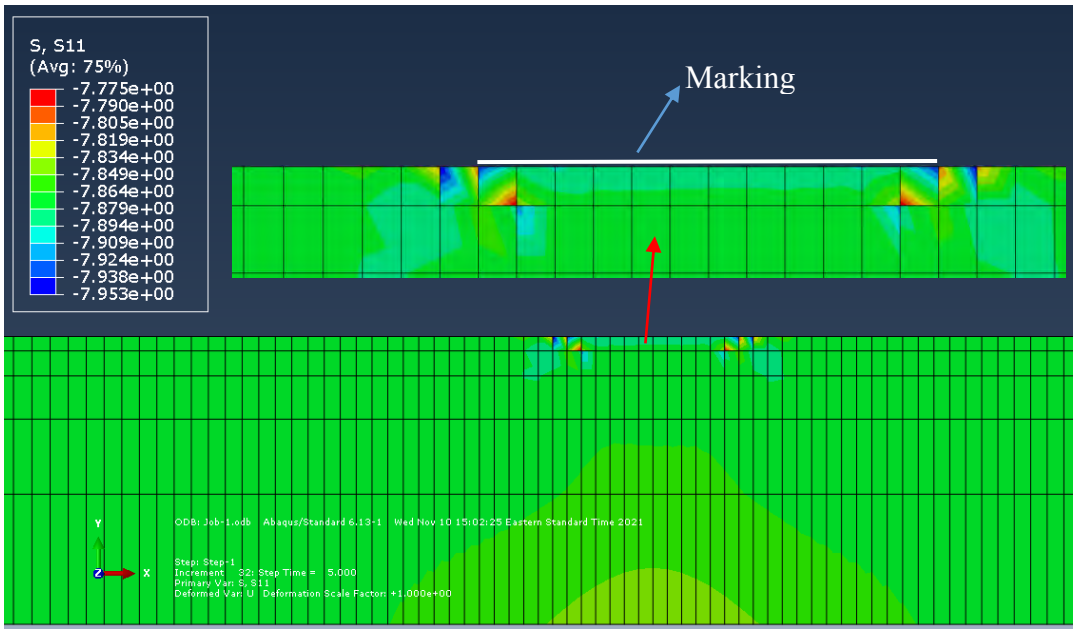
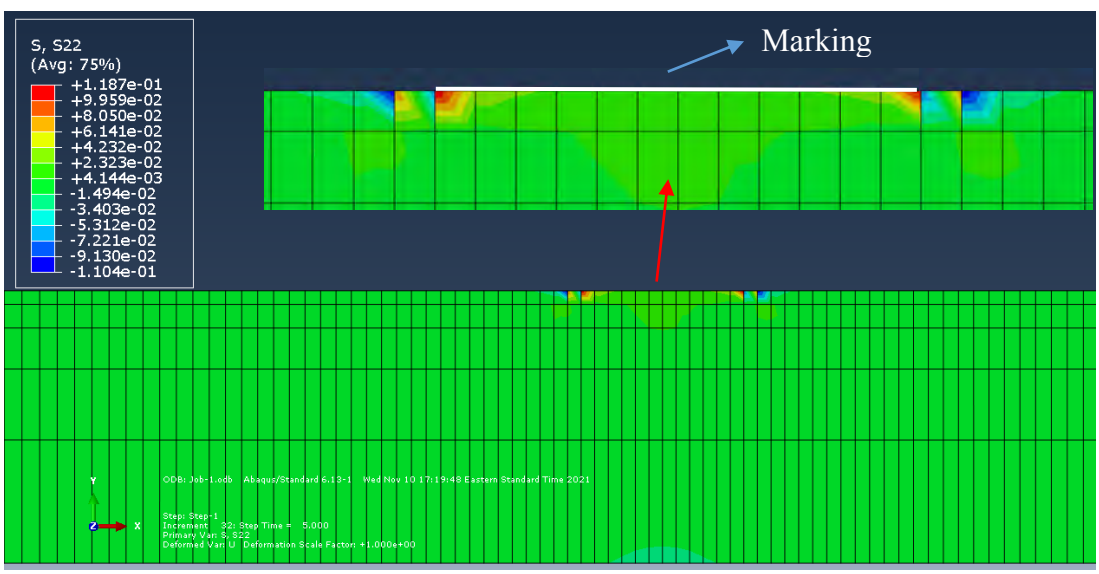
High-stress gradients in both horizontal and vertical directions are observed between marking and asphalt surfaces as shown in Figure 37. Since stresses are calculated assuming elastic behavior, very high values are observed between marking and asphalt surfaces (details can be seen in magnified plot in Figure 37). These high stresses are stress singularities that do not exist in practice. When stresses increase beyond the tensile strength of an asphalt layer, cracks would initiate and the stresses would be released. Since asphalt material has viscoelastic behavior and presents healing properties in the field, the results presented using this elastic model might not be representative. In any case, points with high stresses represent locations which can develop cracking exposing the effect of thermal differentials between pavement and marking surfaces.

Figure 37: Stresses in the (a) transverse and (b) vertical direction

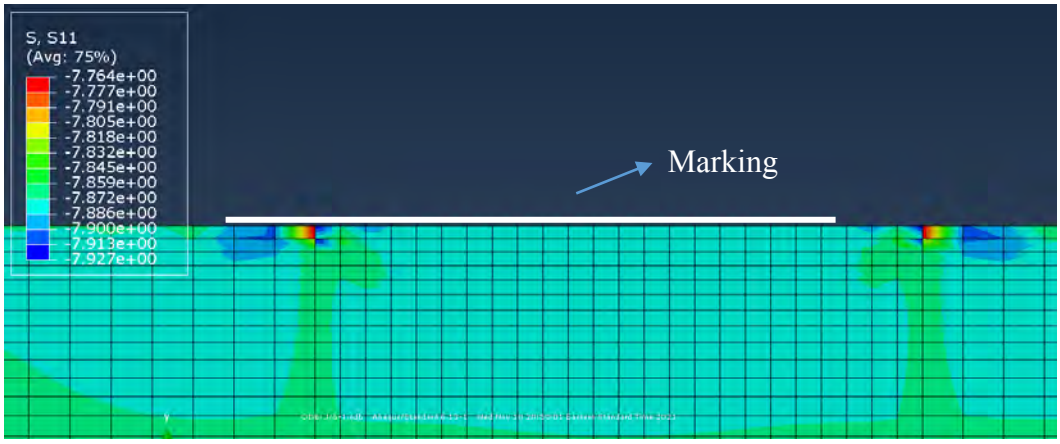
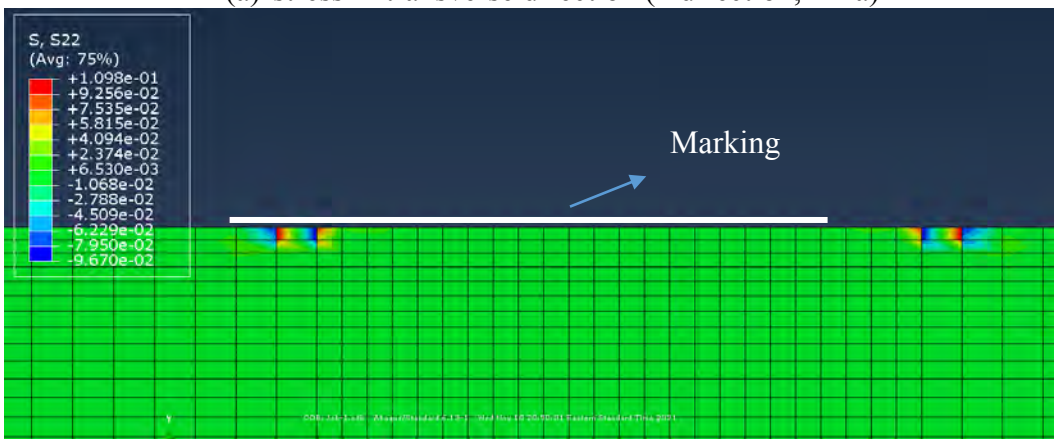
Figure 38: Simulation results using a finer mesh

directions are shown in Figure 38. Comparing Figure 37 with Figure 38 shows the effect of a smaller mesh size. Maximum stresses (in x and y direction) are still observed, which proves that the stresses are stress singularities or point stresses.

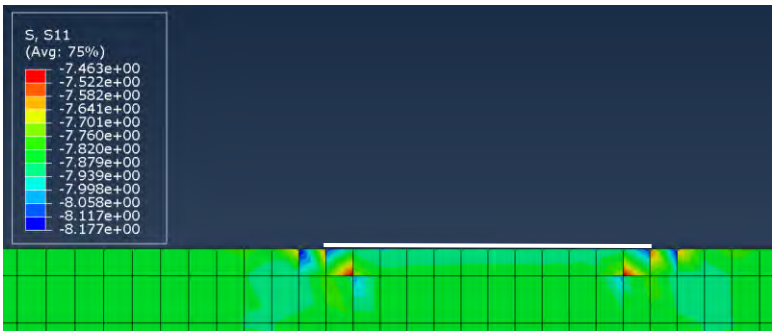
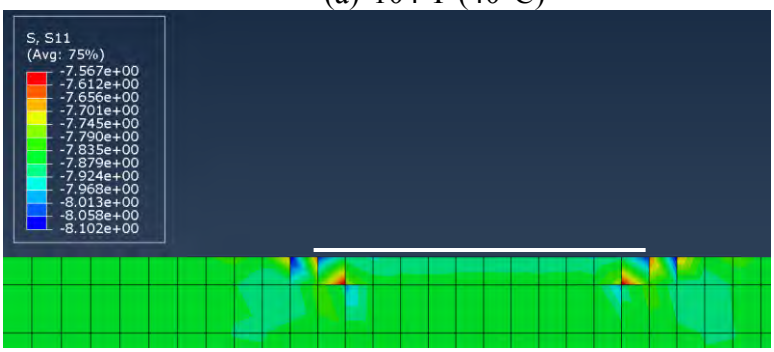
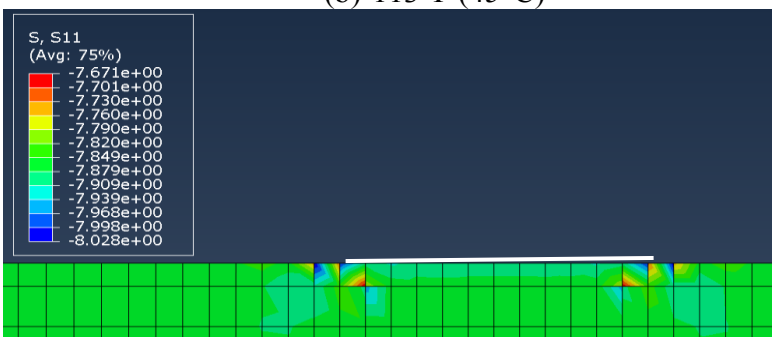
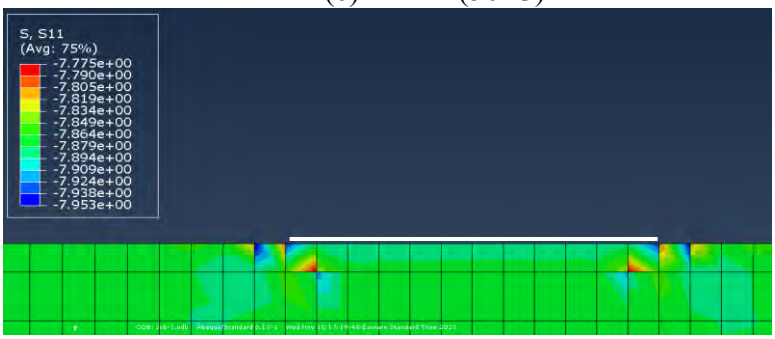
With the increase in temperature of the marking area, the temperature difference between asphalt surface and marking surface decreases and the magnitude of tensile stress singularities decrease as well. This further indicates the potential damaging effect of the temperature difference caused by the different absorptivity of the pavement and marking.

Figure 39: Transverse stress (MPa) variation with marking temperature

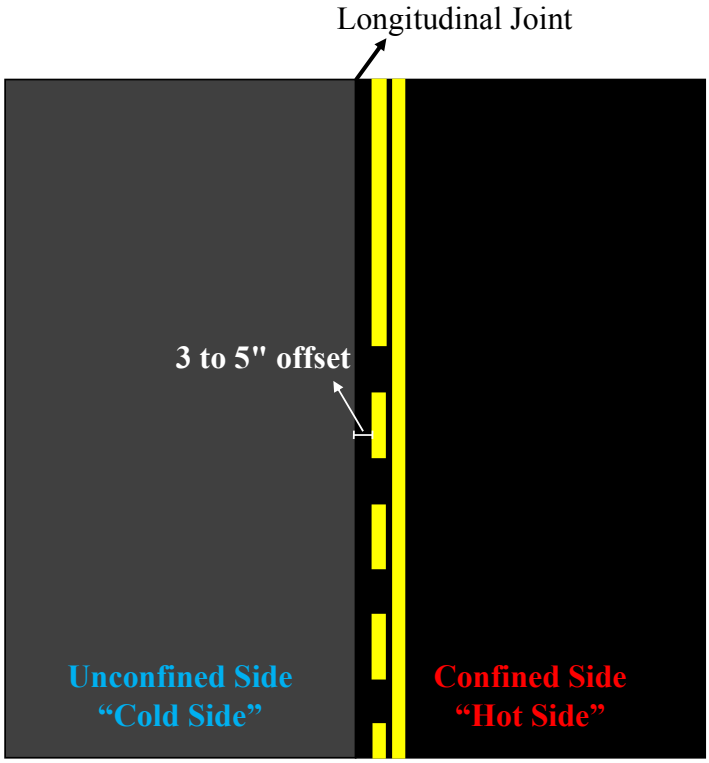
Figure 41: Suggested pavement marking placement

If possible, regarding the geometric design of the road, the marking should be placed on the confined or "hot" side of the joint, i.e., the side which was constructed last. This will ensure the marking is placed over the joint side which presents significantly higher levels of compaction and is less likely to present premature distresses.

In addition, like current practices adopted by the Turnpike Commission, the marking should be placed 3 to 5 in outside of the joint. Results from the ultrasonic testing showed an increase in asphalt density 3 in from the longitudinal joint indicating that higher levels of compaction can be achieved in the near proximity of the joint.
