*Landslide Impacts
to Infrastructure:
State of Practice.*

Presented by
BRIAN F. HEINZL, PE – Geotechnical Project Manager
Gannett Fleming, Inc.

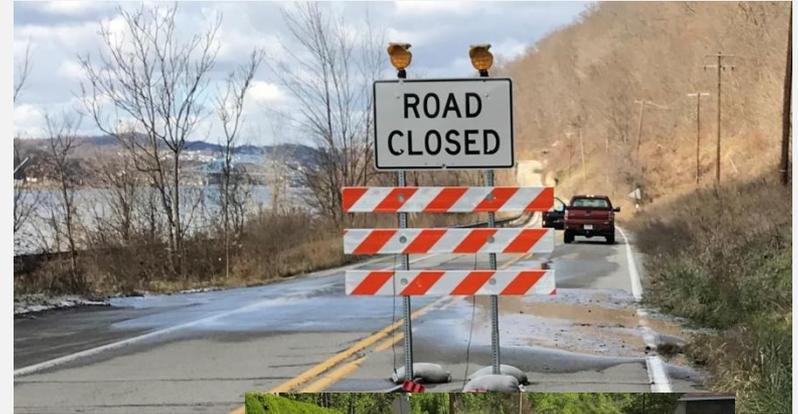
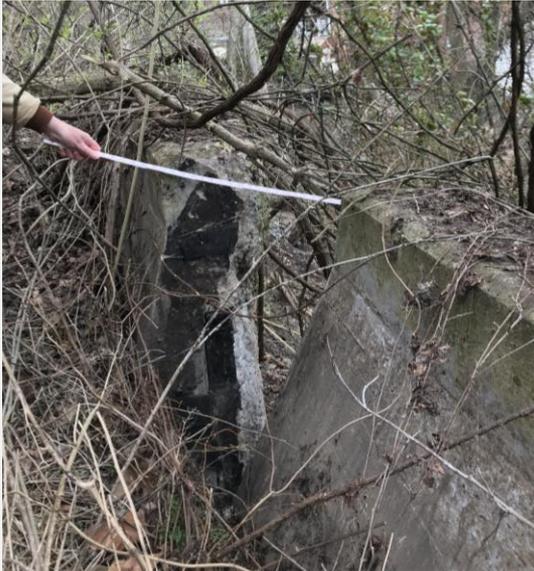
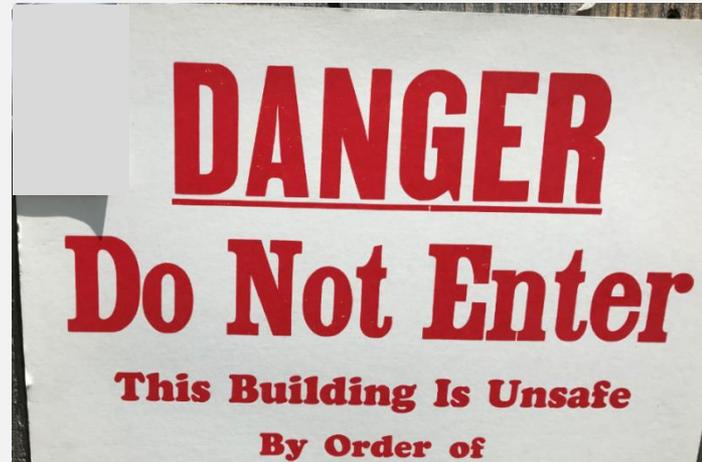
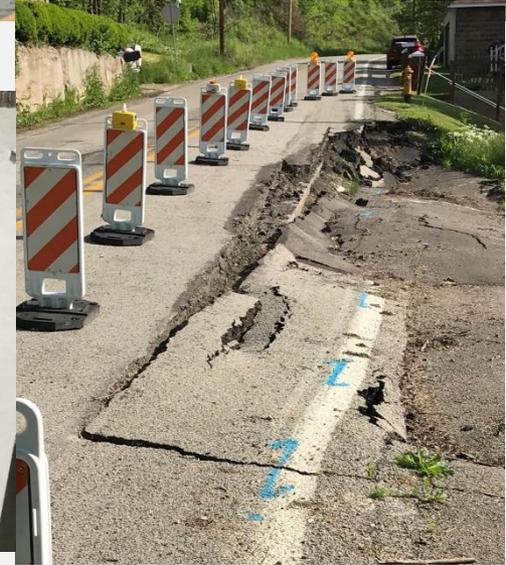
Initial Site Visit

- Limits of movement
- Water presence / patterns
- Proximity to adjacent facilities
- Structure presence or conditions.
- Presence/absence of bedrock

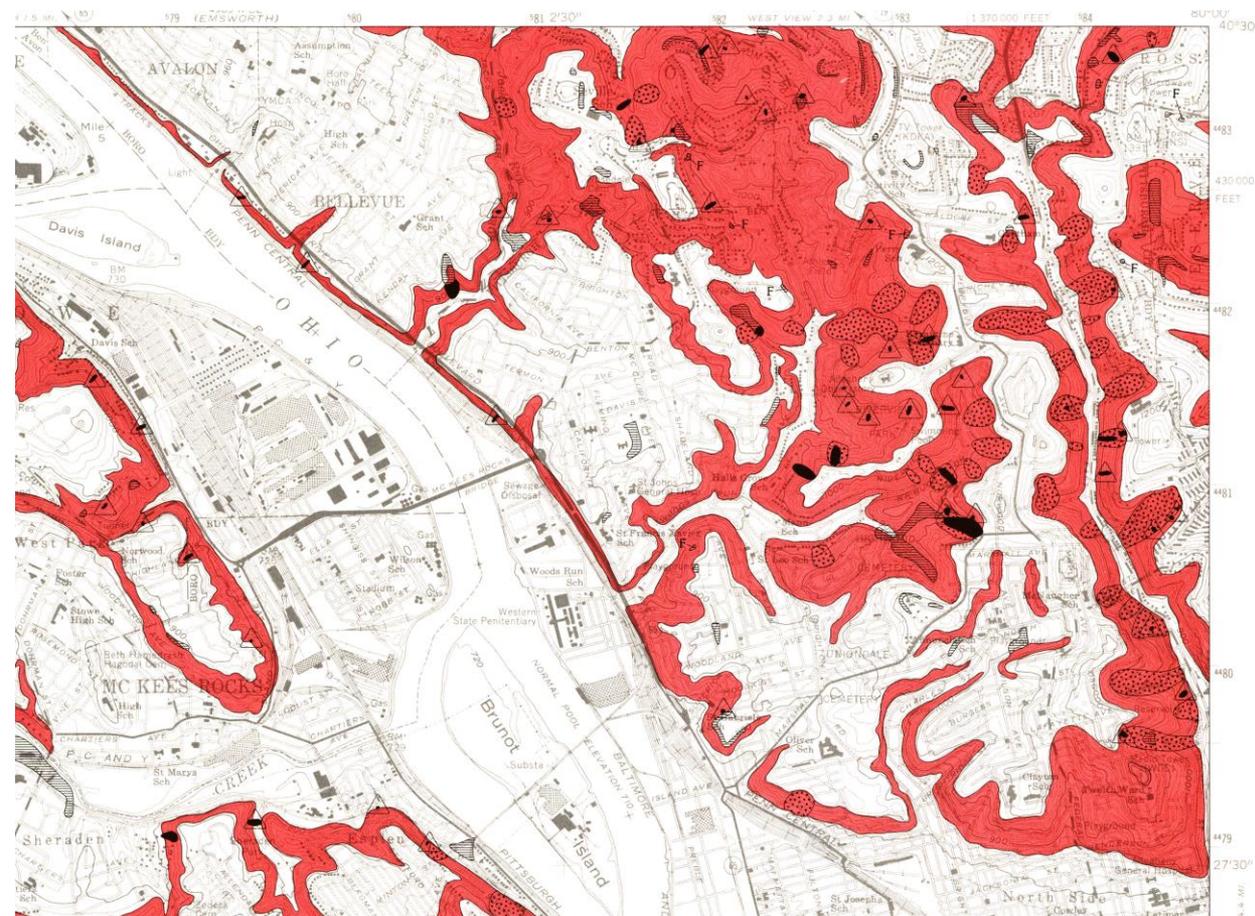
Landslide Susceptibility Maps – USGS 1977

RECENT LANDSLIDES—Predominantly slumps and earthflows (fig. 4 B, C) historically recorded or characterized by fresh scars observed in 1974. Small landslides enclosed by triangles

PREHISTORIC LANDSLIDES—Predominantly slumps and earthflows (fig. 4 B, C) characterized by uneven, hummocky ground surfaces and slump benches; relatively stable in natural undisturbed state, but can be reactivated by excavation, loading, or changes in ground-water and surface-water conditions. Areas shown probably include some recent undocumented landslides and landslides not recognized during field reconnaissance

SLOPES WITH MODERATE TO SEVERE SUSCEPTIBILITY TO LANDSLIDING—Chiefly areas underlain by thick redbeds and associated rocks of the Glenshaw and Casselman Formations. Red mudstone weathers rapidly on exposure; landsliding and creep (fig. 4A, E) often occur in thick reddish clayey soil. Prominent redbeds ("Pittsburgh redbeds") are below the Ames Limestone Member of the Glenshaw, and a lesser known sequence ("Clarksburg redbeds") is above the Ames Limestone Member. Generally cuts and fills in redbeds are not stable

SLOPES WITH SLIGHT TO MODERATE, LOCALLY SEVERE, SUSCEPTIBILITY TO LANDSLIDING—Chiefly areas underlain by weathered claystone and shale of the Casselman and Pittsburgh Formations on which landsliding is infrequent; soil creep, however, is conspicuous. Overloading caused by improper placement of fills or structures can greatly accelerate slope movement

GROUND WITH HIGHLY VARIABLE SLOPE CONDITIONS—Ground on side with ticks has been disturbed by earth-moving operations related to residential and commercial development and to surface mining of coal. Redbeds are relatively rare. Complex zones of thin to locally thick, stable to unstable soil and weathered rock mantle this area. These conditions combine to prevent consistent classification of slopes on the basis of soil creep. Largely underlain by rocks of the Monongahela and lower part of the Dunkard Groups

STEEP SLOPES MOST SUSCEPTIBLE TO ROCKFALL—Steep, locally vertical, natural and manmade slopes and cliffs 15 ft (4.5 m) to more than 150 ft (45 m) high exposing layers of sandstone, subordinate limestone and flaggy, sandy shale, and interbedded claystone and shale. Sandstone and limestone are often highly fractured and are undercut by relatively rapid weathering of claystone and shale (fig. 4 D)

GROUND WITH LITTLE SUSCEPTIBILITY TO LANDSLIDING—Slopes commonly exhibit slight soil creep but are susceptible to significant landsliding only where extensively modified by man (see map area 1.2 mi (2 km) southwest of Brunot Island

MANMADE FILL—Heterogeneous soil and rock material with variable susceptibility to slope failure depending on nature of material, foundation conditions, design, and construction. Fills in redbed areas commonly contain red bedrock and soil which rest on redbeds and, therefore, are less stable than similarly constructed fills in other areas. Fills in older urbanized areas and fills resulting from mining are shown only where associated with significant recent landslides. Many fills are too small to show by pattern and are identified by letter "F"

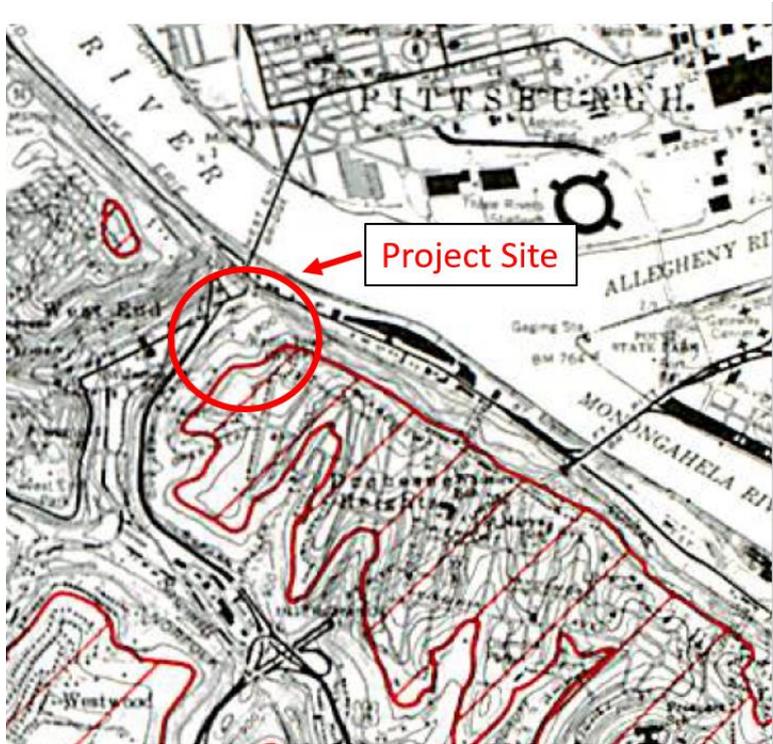
Mine Maps

USGS Mined Out Areas

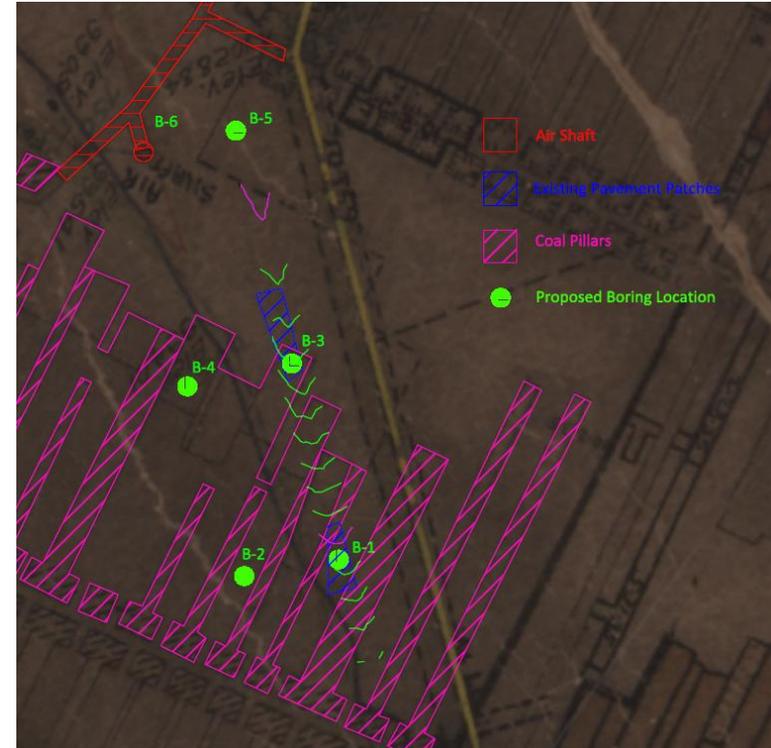
DEP detailed mine map overlays

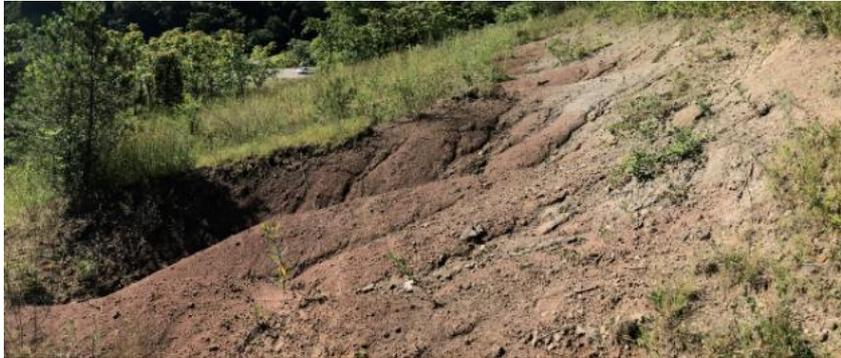
- Subject to weathering and loss of shear strength when exposed to air, water and repetitive weathering cycles

Erosion of Pittsburgh Redbeds along existing 3H:1V cut slope along I-79 near Neville Island

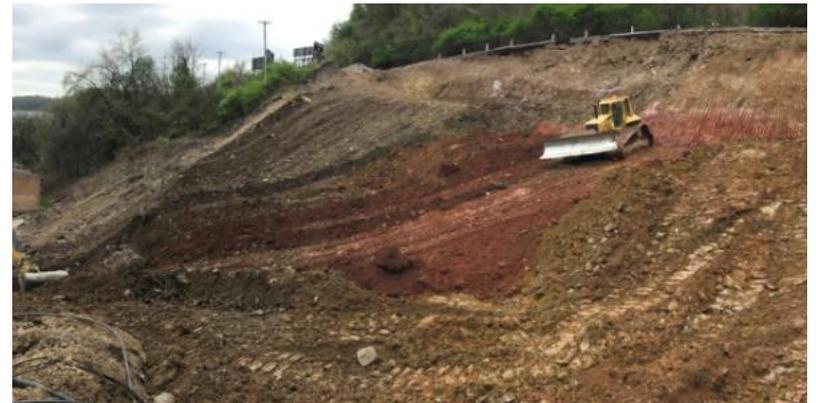
Excavation of Schenley Red Beds during landslide remediation

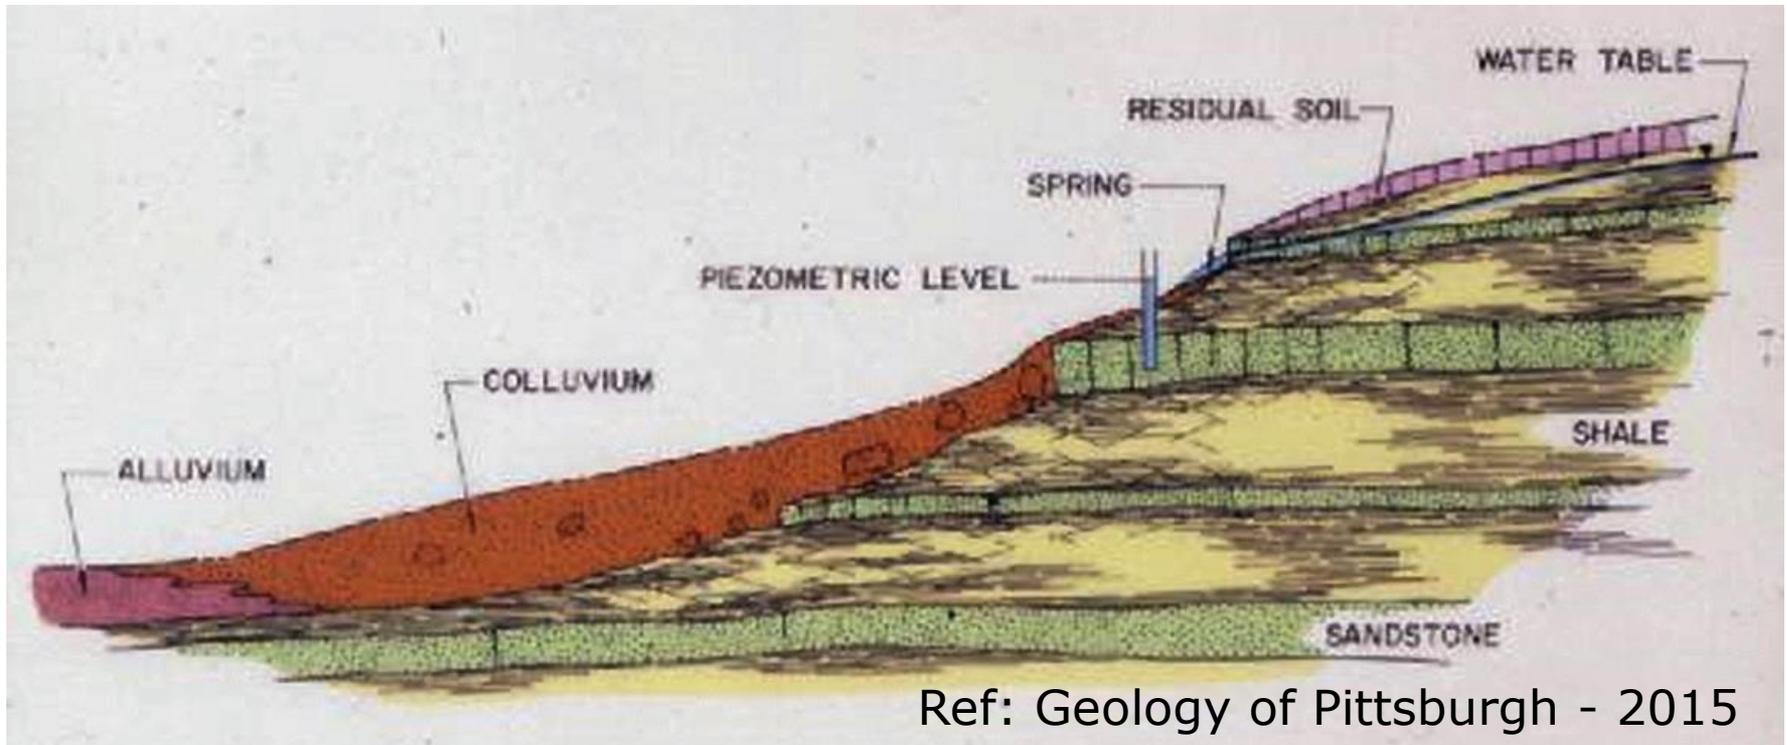
- Soil deposits formed by downslope accumulation of upland parent materials at or near the toe of slope.
- Low strength properties; subject to continued creep or movement especially when disturbed by cutting, filling, drainage changes, or extreme precipitation events

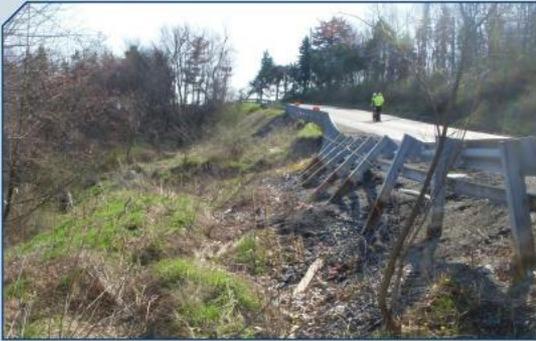
- Gabion baskets
- Re-paving
- Rock fill
- Re-alignment
- Patching

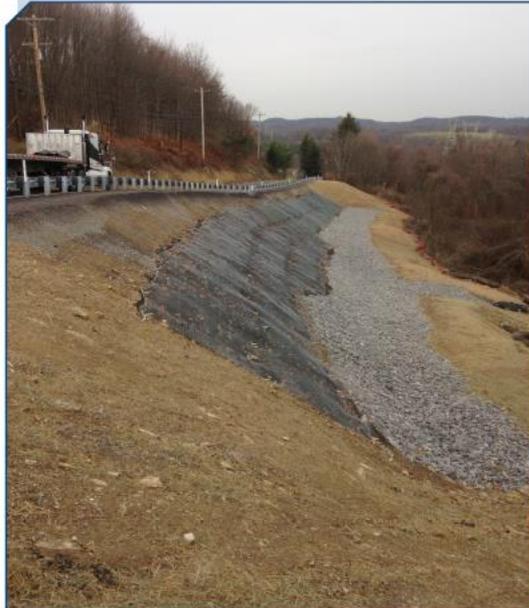
- Persistent groundwater issues
- Complex geology – landslide-prone soils, thick colluvial slopes, and deep residual claystone
- Maintain traffic through construction to avoid a 17-mile detour for emergency vehicles, school buses, and local drivers.
- Public safety under temporary construction conditions – 5,000 vehicles per day.

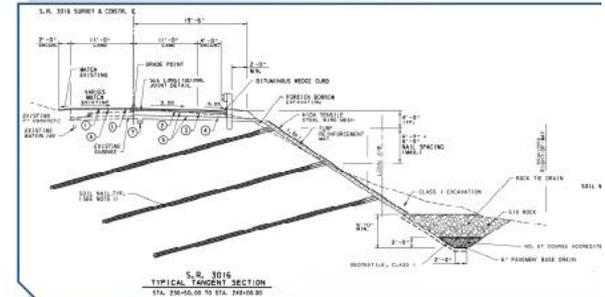
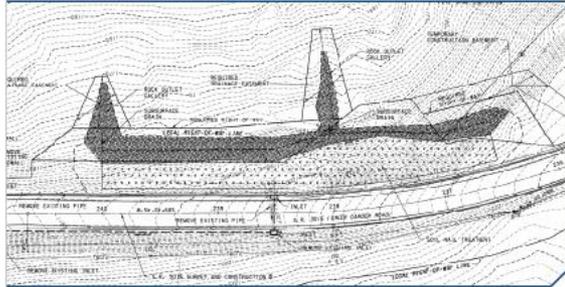
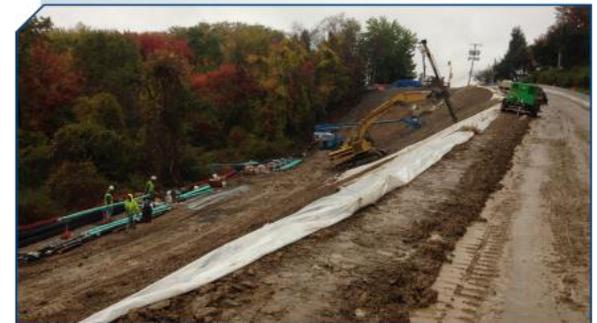
SOIL NAIL TREATMENT

- Allowed for sufficient temporary stability during construction to maintain traffic through single lane conditions.
- Variable cross section - 3 to 4 rows of soil nails
- Added rock toe for improved stability and long-term drainage of treatment area
- Treatment length – Approximately 350 feet
- Final treatment cost = \$ 1,232,000

Repair Type	Project	ECMS	Year	Bid Price	Length	# Lanes	Cost/LF/Lane
ROCK BUTTRESS	SR 151 B05	93060	2012	\$ 1,232,000.00	775	3	\$ 529.89
GEOGRID REINFORCED SLOPE	SR3054 A07	107313	2016	\$ 608,085.00	450	2	\$ 675.65
SOIL NAILS	SR3016 B09	28996	2012	\$ 1,232,000.00	770	2	\$ 800.00
CAISSONS / ROCK EMBANKMENT	SR2065 A07	92532	2012	\$ 968,726.00	525	2	\$ 922.60
ROCK BUTTRESS	SR 2086 A03	87381	2010	\$ 343,000.00	185	2	\$ 927.03
CAISSONS/MINE GROUTING	SR3028 SLD	80799	2008	\$ 828,112.00	425	2	\$ 974.25
SOIL NAILS	SR2018 A04	102690	2014	\$ 985,450.00	500	2	\$ 985.45
ROCK/SOIL NAILS/GRS	SR4070 A18	105384	2016	\$ 2,607,655.00	1170	2	\$ 1,114.38
ANCHORED WALL	SR2001 A18	109324	2017	\$ 1,793,000.00	585	2	\$ 1,532.48
CAISSONS	SR51 A64	28491	2006	\$ 2,193,924.00	655	2	\$ 1,674.75
ROCK BUTTRESS/MINE GROUTING	SR2017 A07	N/A	2013	\$ 1,102,150.00	300	2	\$ 1,836.92
CAISSONS / GEOFOAM	SR4063 A05	92828	2011	\$ 2,483,491.00	550	2	\$ 2,257.72

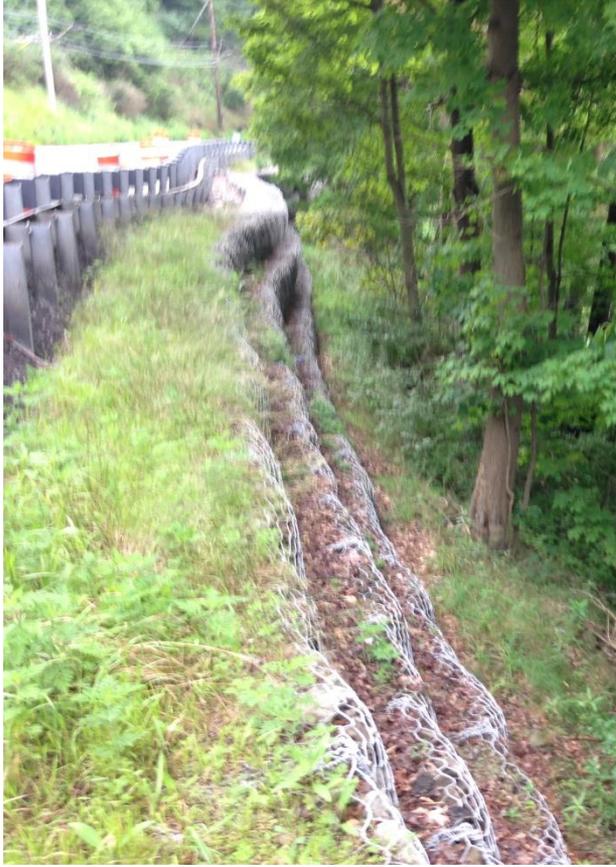
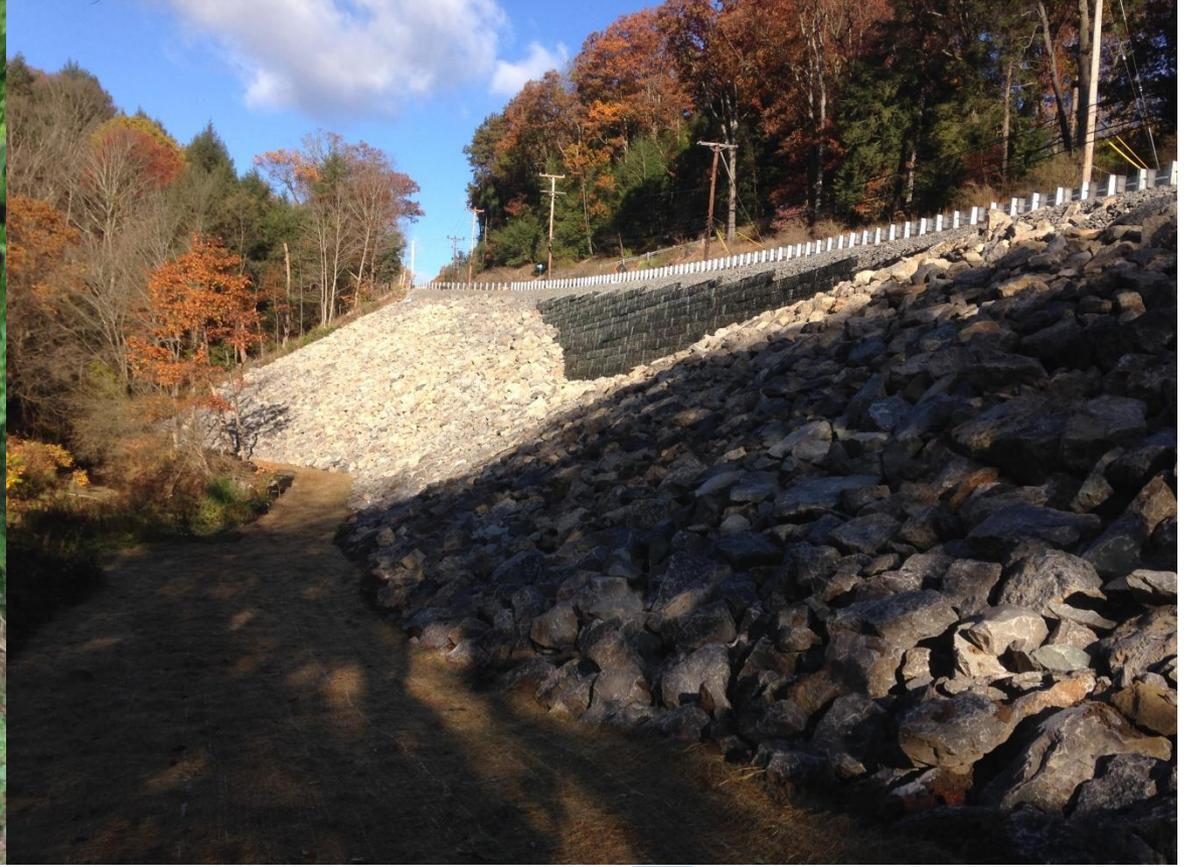
SR 4070 – Wildwood Rd. GRS & Rock Embankment

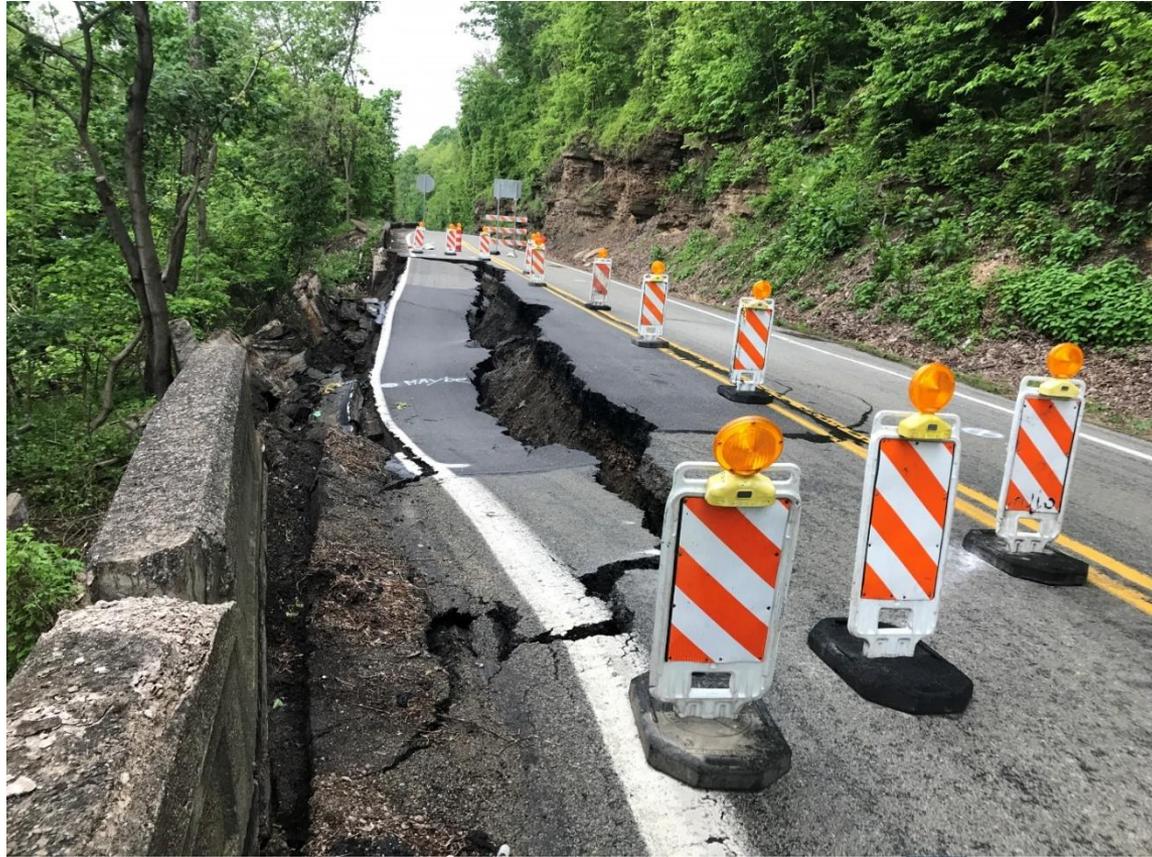
SR 2001 Retaining Wall

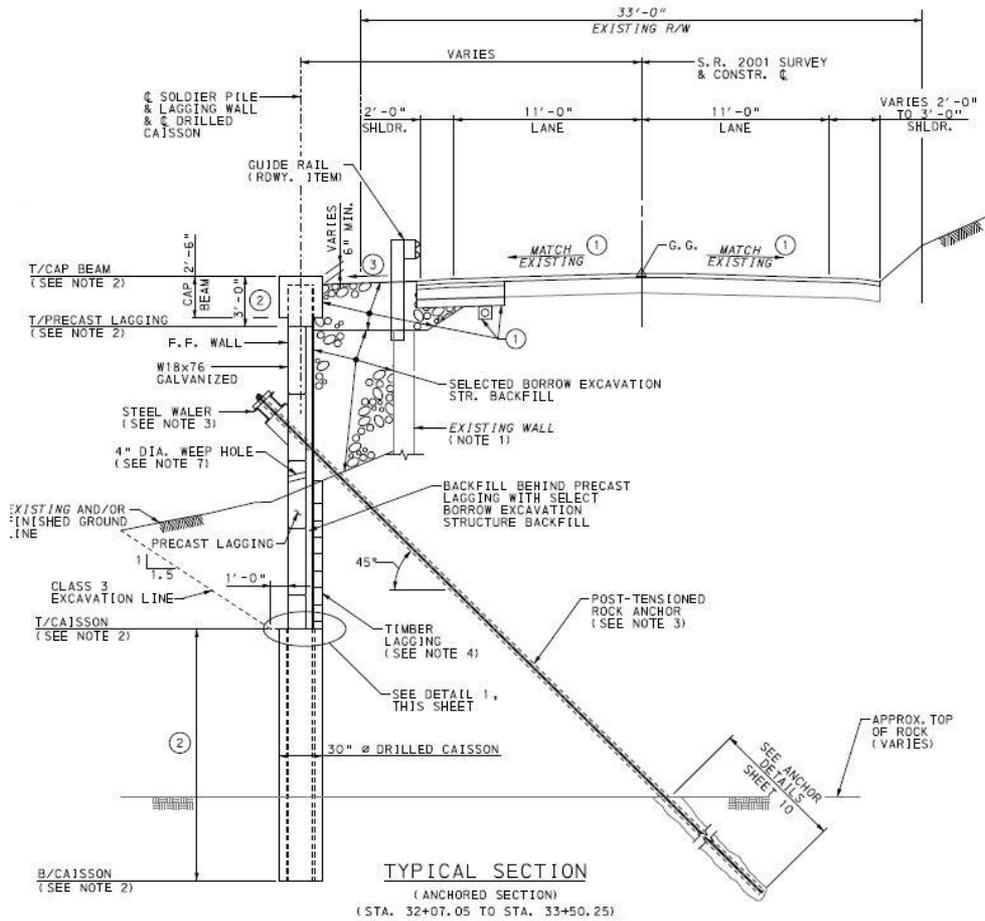
SR 2001 Retaining Wall

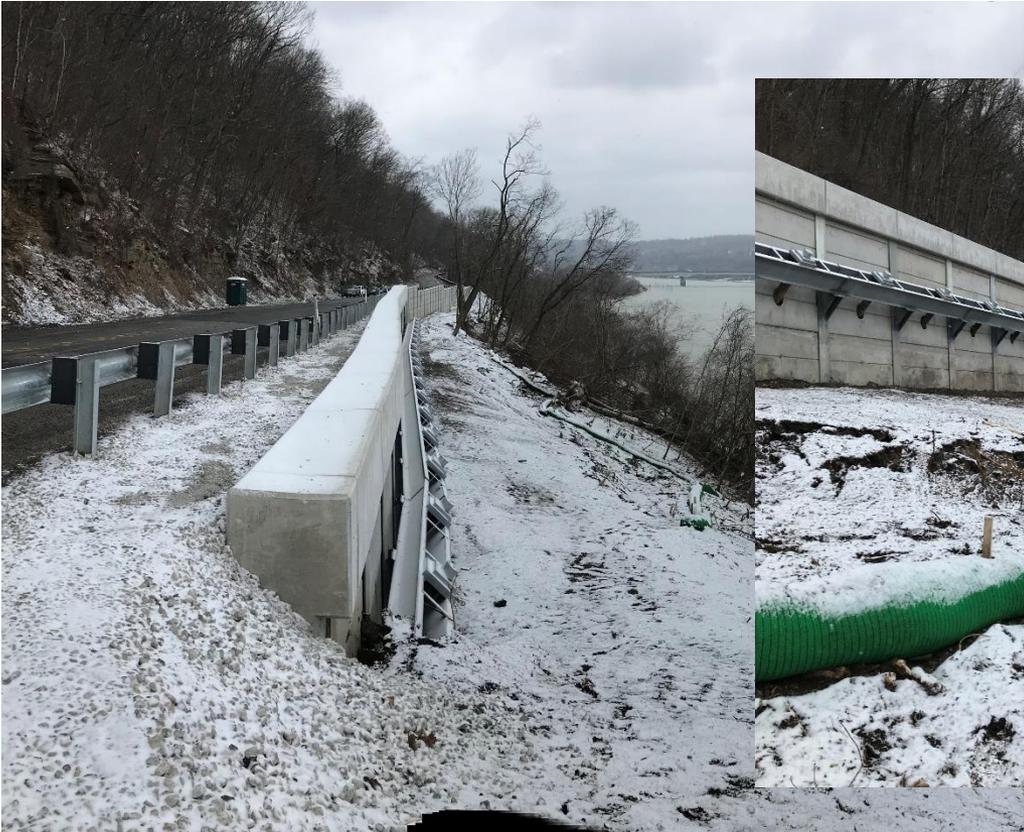
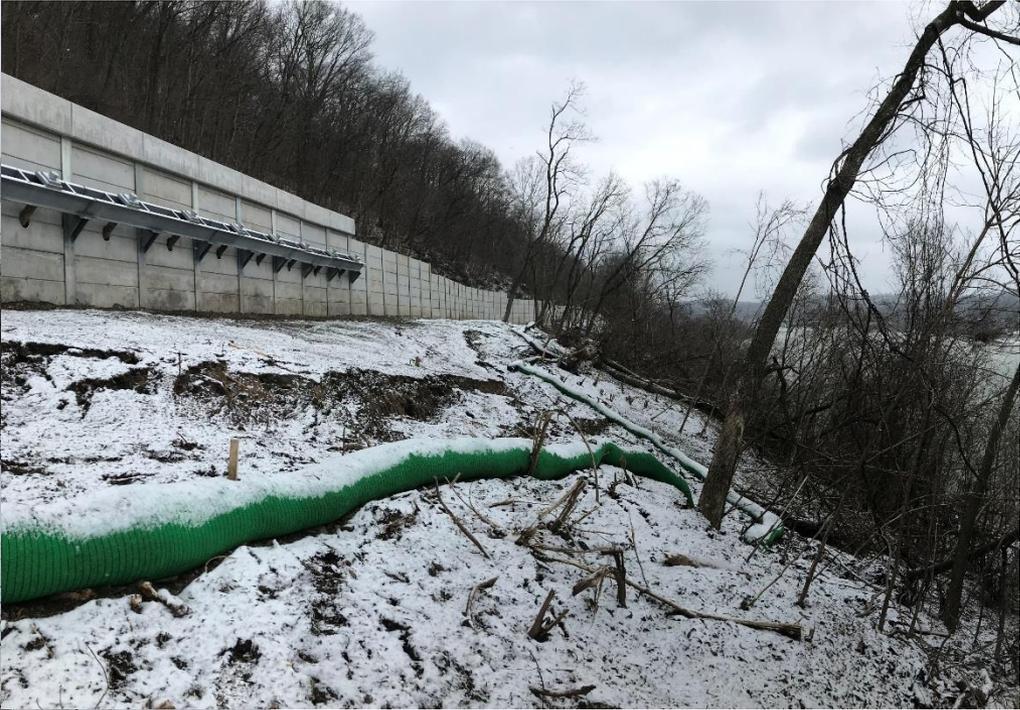
SR 2001 Retaining Wall
